**CITY OF NORTH MIAMI
PUBLIC WORKS UTILITIES**

**WINSON WATER TREATMENT PLANT
RELIABILITY IMPROVMENTS**

EXHIBITS

***INSPECTION AND CLEANING OF THE 750,000-GALLON
WELDED STEEL WATER STORAGE TANK***

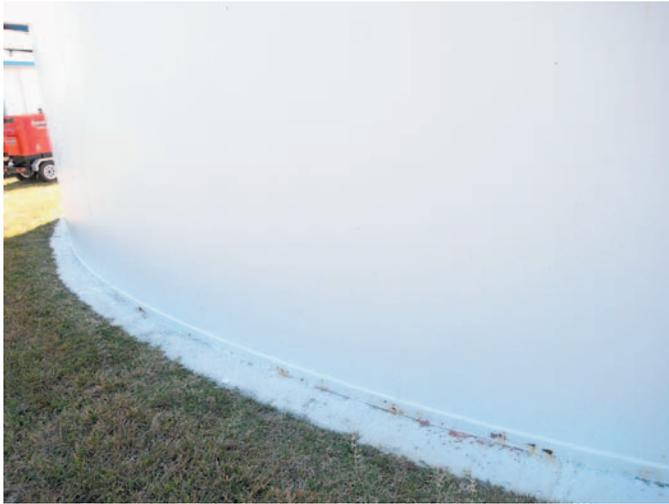
1 *Exterior Wall Surfaces Found With Coating Chips, Exposed Steel And Mild Surface Corrosion*

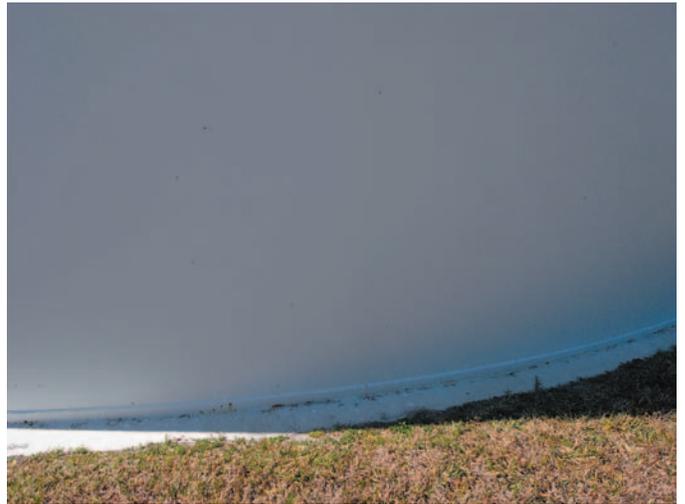
2 *Exterior Wall Surfaces Found With Coating Chips, Exposed Steel And Mild Surface Corrosion*

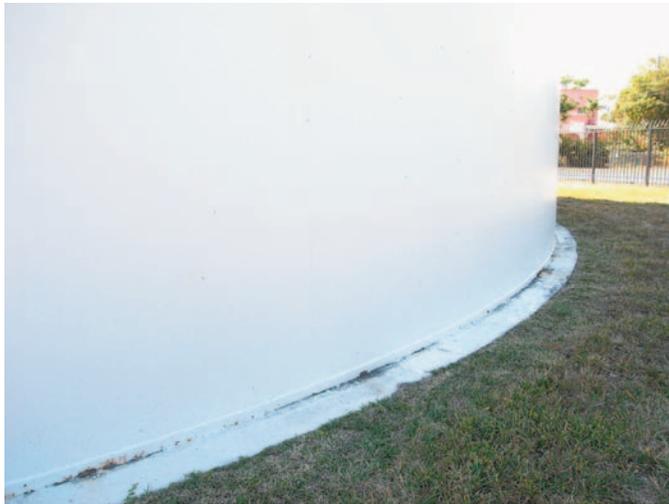
3 *Exterior Wall Surfaces Found With Coating Chips, Exposed Steel And Mild Surface Corrosion*

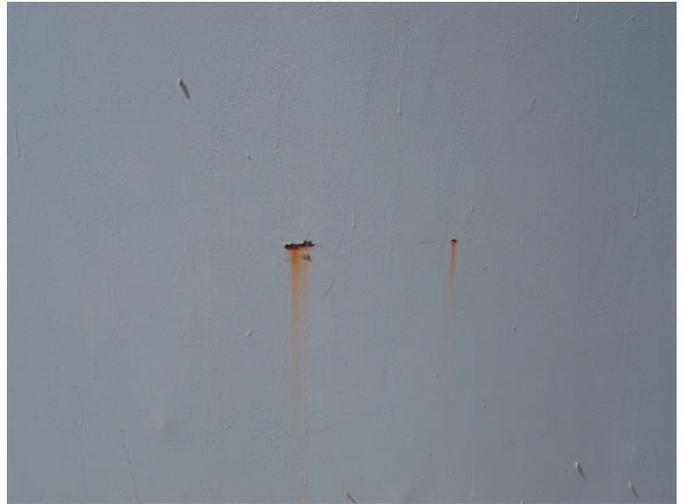
4 *Exterior Wall Surfaces Found With Coating Chips, Exposed Steel And Mild Surface Corrosion*

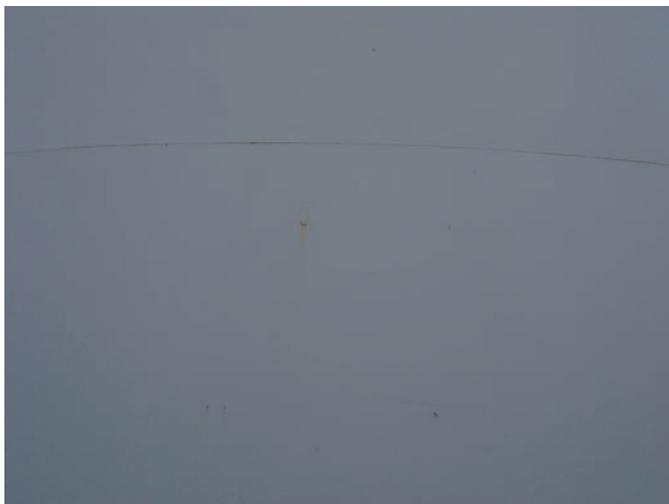
5 *Exterior Wall Surfaces Found With Coating Chips, Exposed Steel And Mild Surface Corrosion*

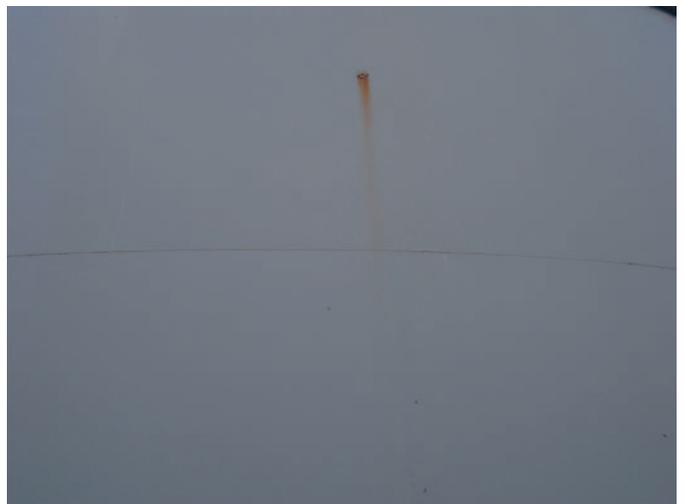
6 *Exterior Wall Surfaces Found With Coating Chips, Exposed Steel And Mild Surface Corrosion*
