On February 10, 2009, Underwater Solutions Inc. conducted an inspection of the 1.5-million gallon welded steel water storage tank to provide information regarding the overall condition and integrity of this structure and removed the sediment accumulation found on the floor of the structure.

On February 11, 2009, Underwater Solutions Inc. conducted an inspection of the 250,000-gallon concrete clearwell to provide information regarding the overall condition and integrity of this structure and removed the sediment accumulation found on the floor of the structure.

In 2007 the City prepared a report titled Winson Water Treatment Plant Expansion Feasibility Study indicating that the existing treatment systems and Biscayne Aquifer wellfield infrastructure were at or near the end of their useful life. Based upon subsequent on-site observations and discussions with City staff, H&S generally concurred with these recommendations. To this end, the City determined that WTP facilities should be rehabilitated via the Bid Package 3: WTP Rehabilitation Project proposes to ensure continued reliability through the year 2030. Due to budget constraints, the existing treatment capacity will remain fix

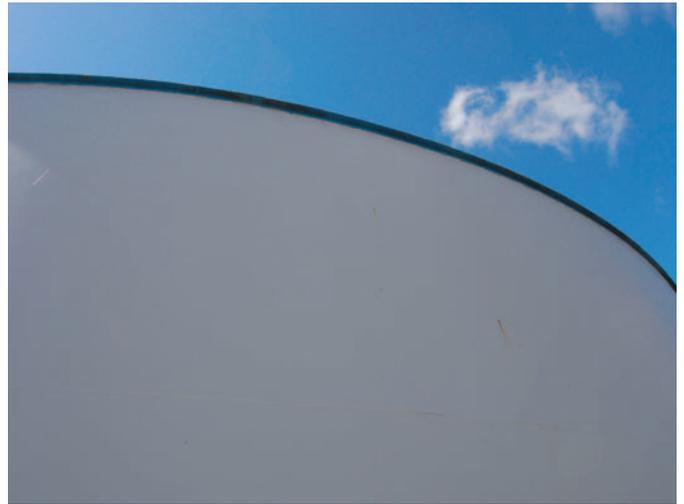
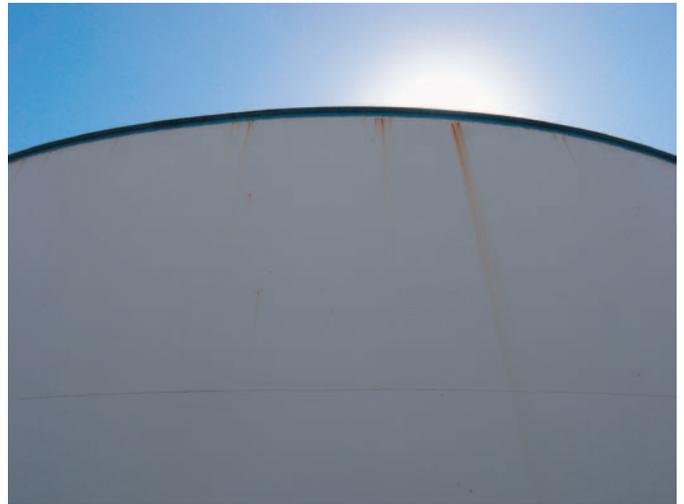
7 *Exterior Wall Surfaces Found With Coating Chips, Exposed Steel And Mild Surface Corrosion*

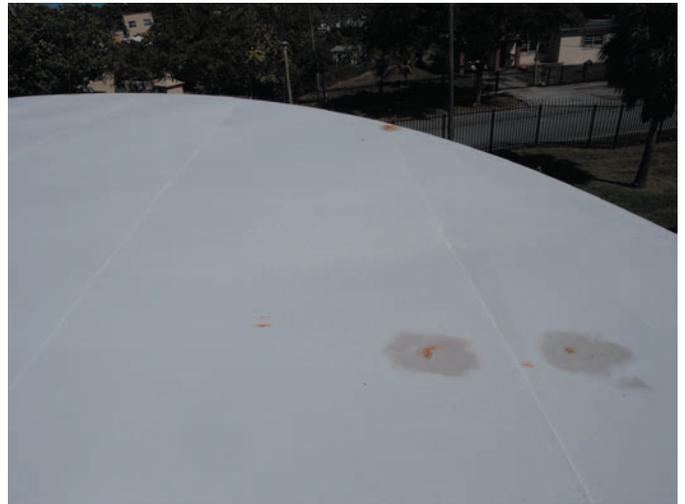
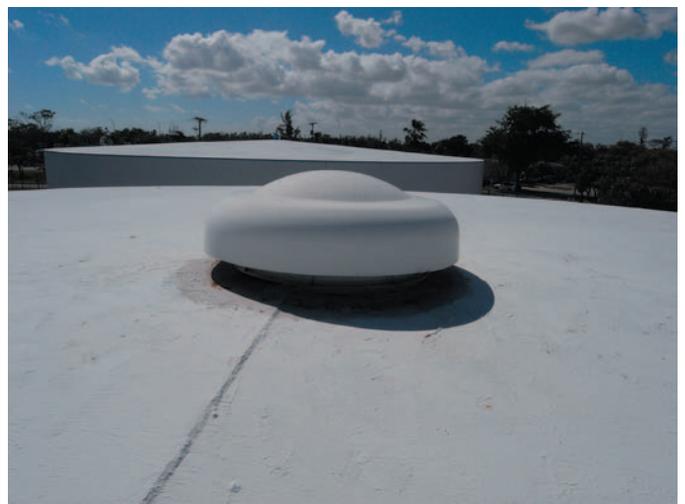
14 *Roof Surfaces Found With Coating Failure, Blotch Rusting And Exposed Steel*

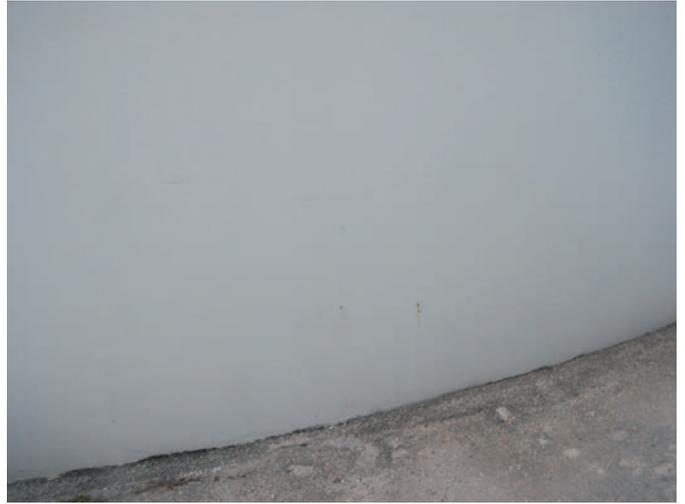
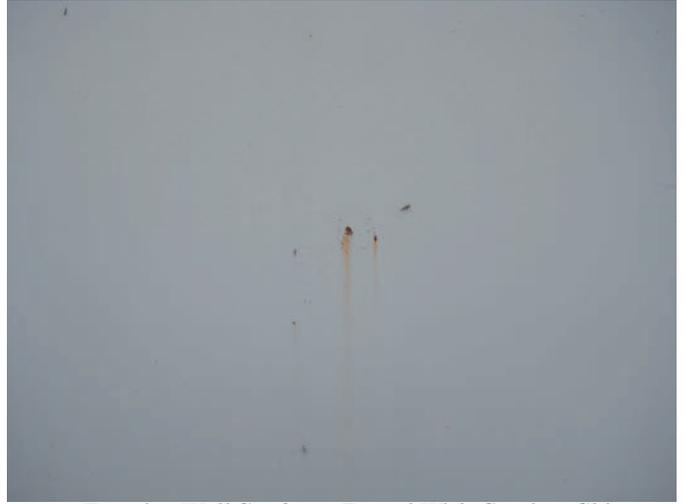
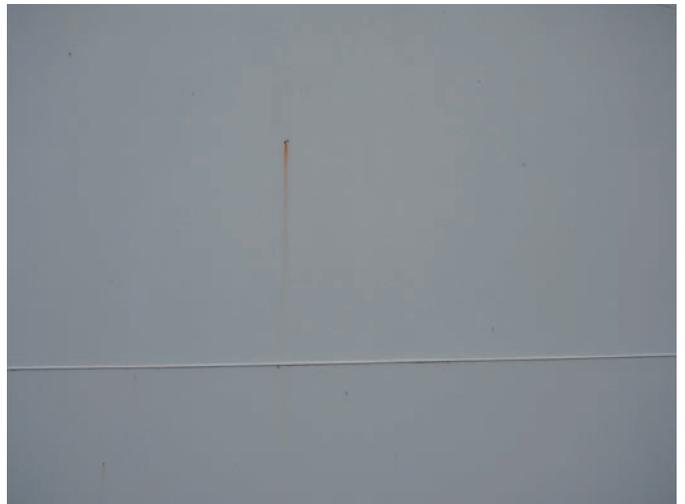
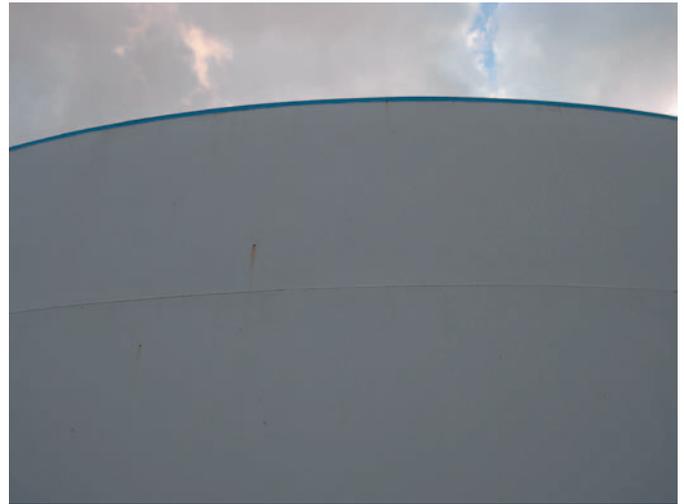
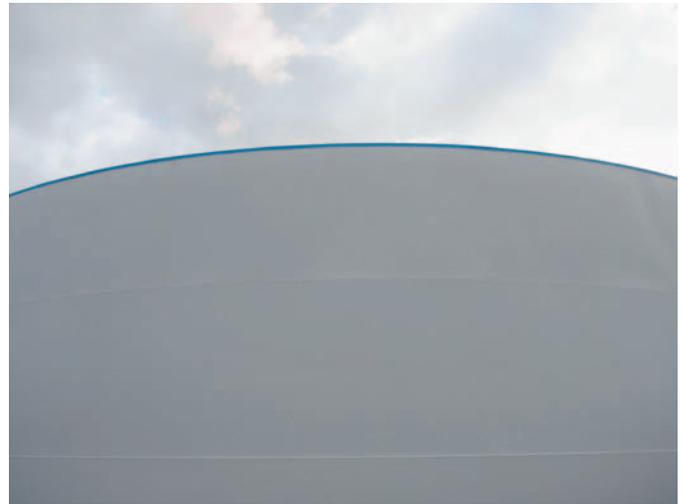
The exterior wall surfaces were inspected and found to appear sound while several coating chips, ranging from 1/8" to 3/4" in diameter, were found on approximately 5% of the walls throughout all elevations of the tank.

These coating chips appear to be the result of objects striking these surfaces and cause mild surface corrosion of the exposed steel.

Several coating chips, appearing to be caused by objects striking these surfaces, have exposed the underlying steel resulting in mild surface corrosion.

1 *Exterior Wall Surfaces Found With Coating Chips, Exposed Steel And Mild Corrosion*

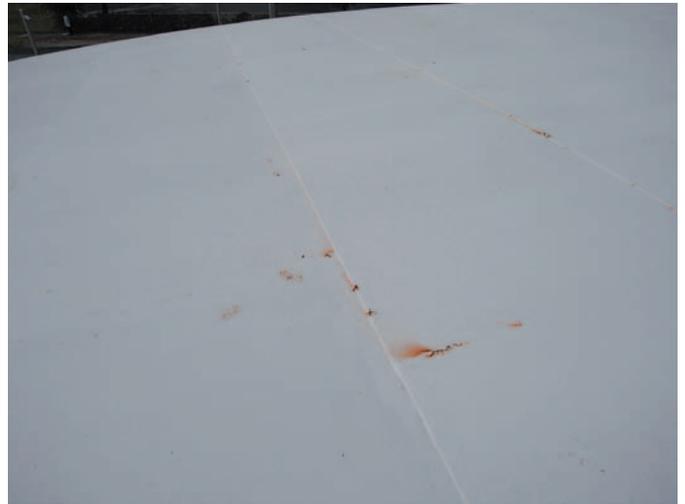
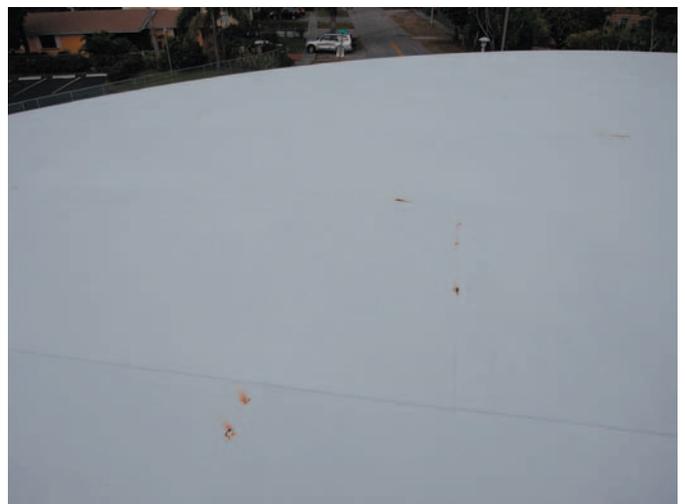
The protective coating applied to these roof surfaces has become weathered, reducing the film thickness. This condition causes poor adhesion value, resulting in cracking of the coating and blotch rusting on approximately 10% of these surfaces.

Within all areas where the protective coating has cracked, exposure of the underlying steel was found, yet no obvious steel fatigue (pitting) was witnessed at the time of this inspection.

The protective coating applied to these roof surfaces was found having poor adhesion value and reduced film thickness caused from weathering, resulting in cracking of the coating and blotch rusting.

14 *Roof Surfaces Found With Coating Failure, Exposed Steel And Surface Corrosion*

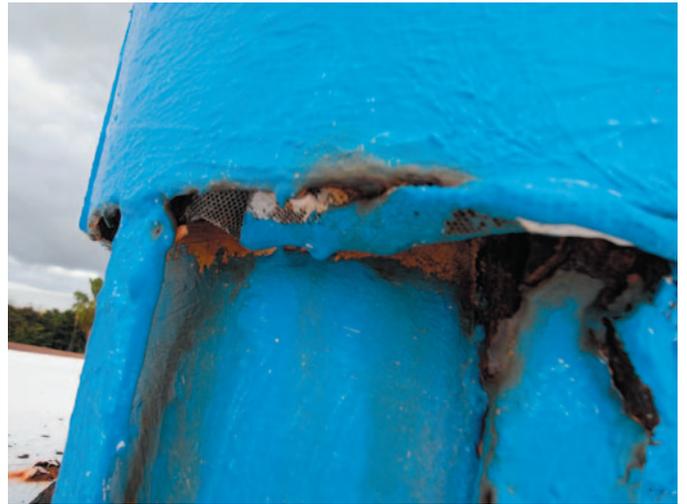
A 14" outside diameter cap was found securely installed over this vent while the perimeter screening is loose, causing gaps between the cap and vent. This condition allows access to the interior of the tank.

20 *Vent Found With Loose Perimeter Screening*

We recommend immediately replacing the screens on both the vent and overflow in an effort to prevent access.

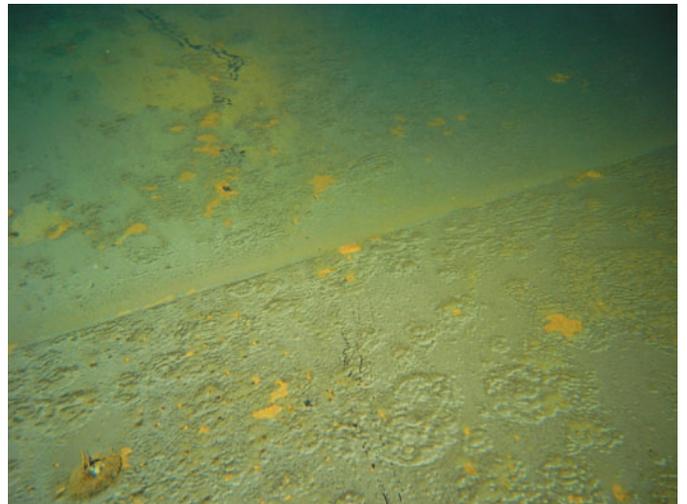
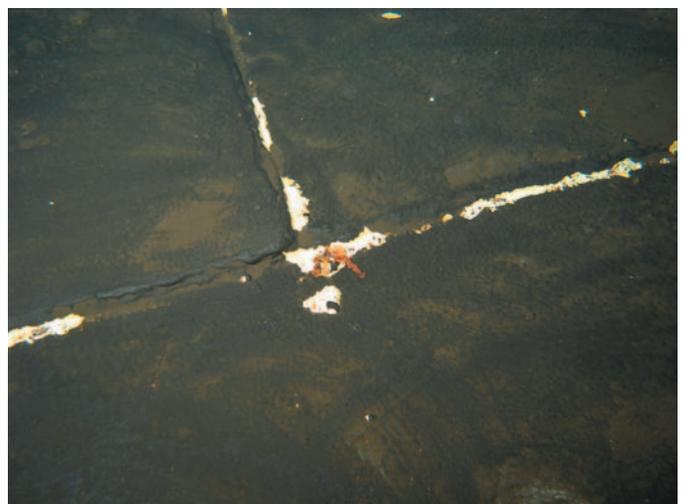
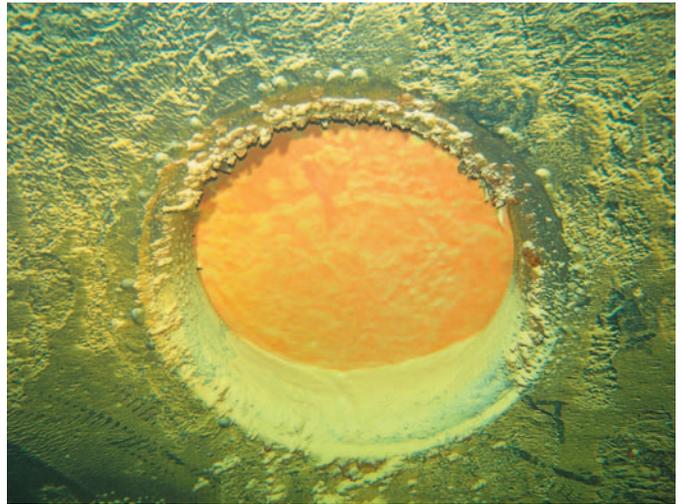
The protective coating applied to these surfaces was found with adhesion loss causing blistering throughout approximately 5% of the floor surfaces.

Approximately 15% of these coating blisters have ruptured, causing exposure of the primary coating system and underlying steel, resulting in moderate surface corrosion.

27 *Floor Surfaces Found With Coating Failure And Surface Corrosion After Cleaning*

We recommend recoating all interior surfaces of the tank using an A.N.S.I. / N.S.F.61 approved coating for use in structures containing potable water and should be done within the near future, as continued exposure of the steel will result in metal fatigue (pitting) and eventually result in failure.

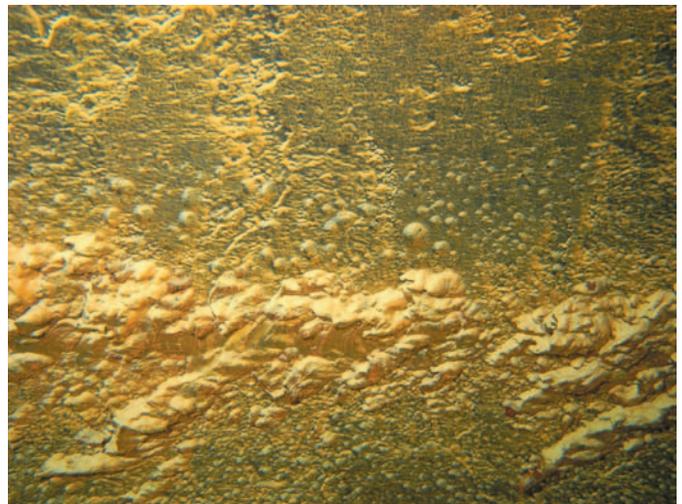
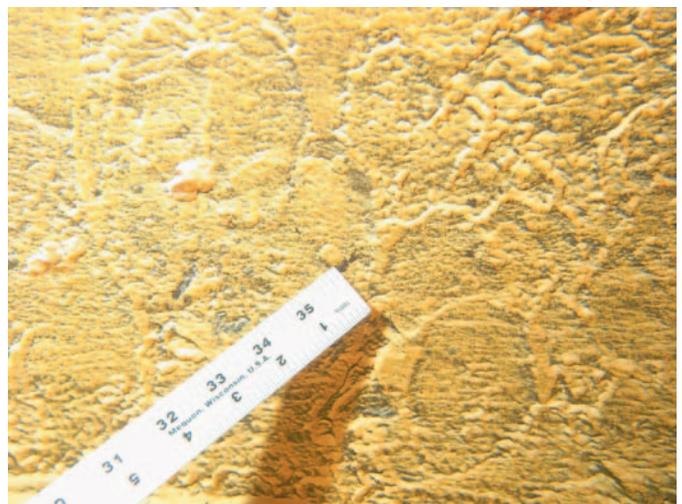
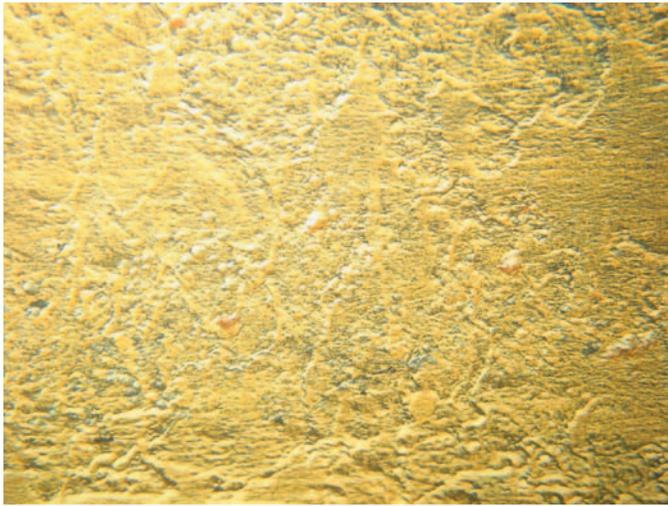
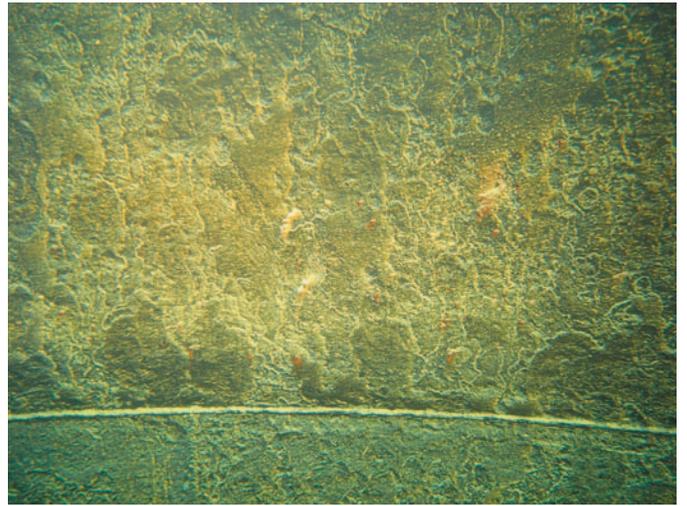
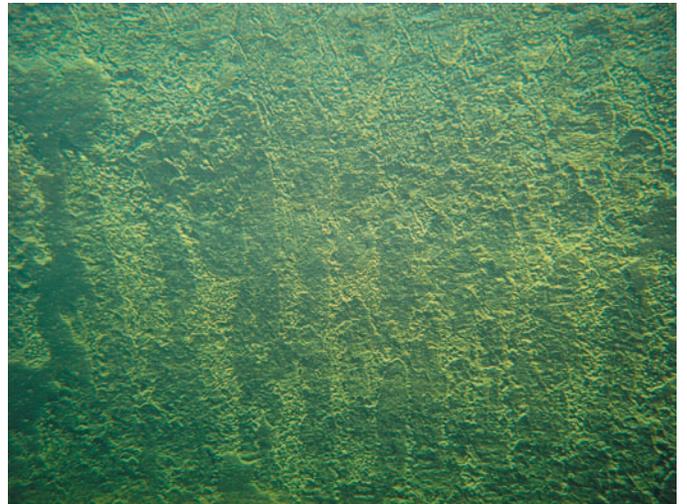
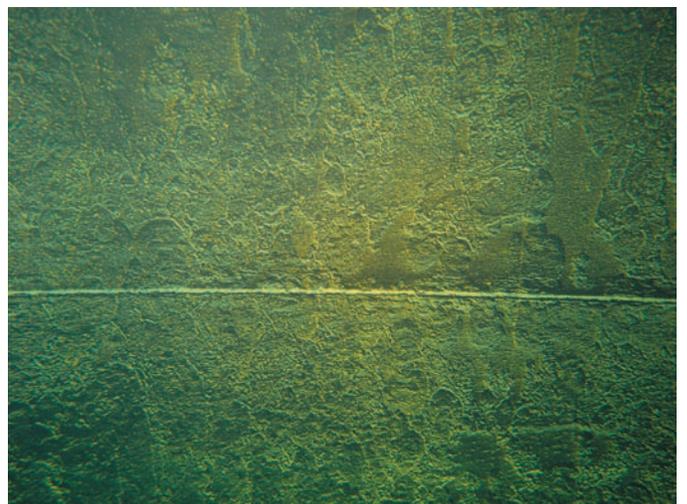
Coating blisters were found throughout approximately 5% of all wall panel surfaces, to include all welds between each panel, due to adhesion loss.

Heavy staining exists on all wall surfaces beginning approximately 10” below the overflow and extending down to the floor.

39 *Interior Wall Surfaces Found With Coating Failure And Staining*

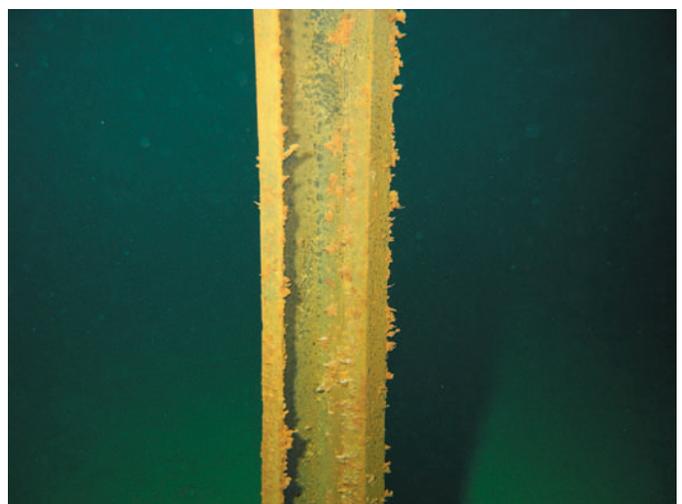
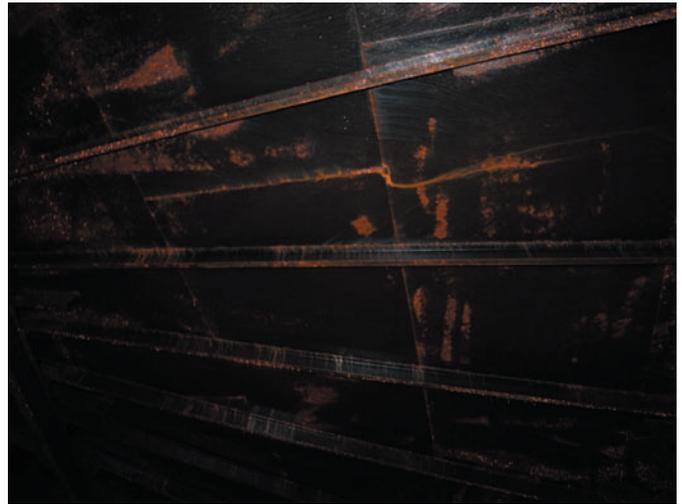
Each column appears sound while the protective coating has failed throughout all elevations of these columns resulting in exposure of the steel causing moderate surface corrosion.

59 *One Of Three Support Column Found With Coating Failure, Exposed Steel And Corrosion*

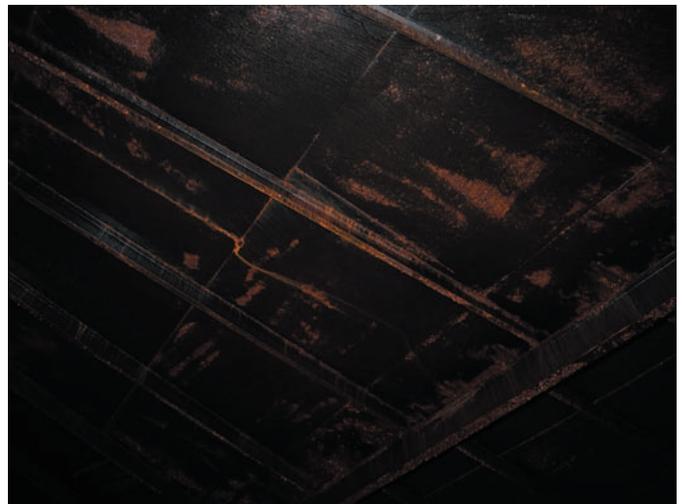
The protective coating applied to these overhead surfaces, to include all supports, appears to have poor adhesion value due to reduced film thickness and expiration. This condition causes blotch rusting to show through the coating throughout approximately 50% of these surfaces at this time.

62 *Overhead Surfaces Found With Poor Coating Adhesion And Blotch Rusting*

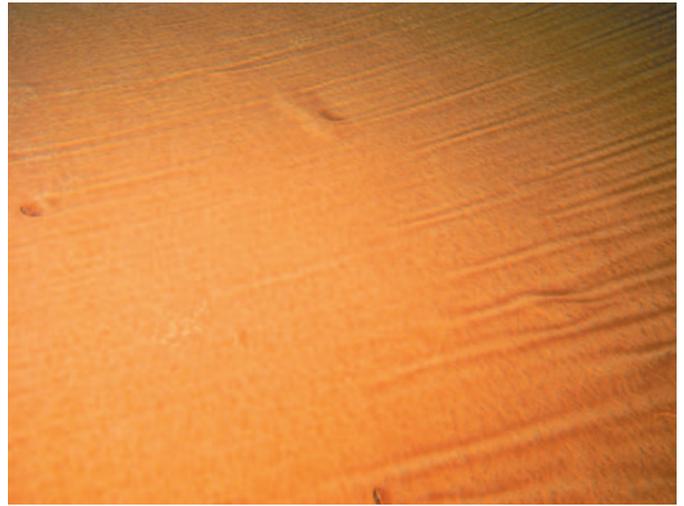
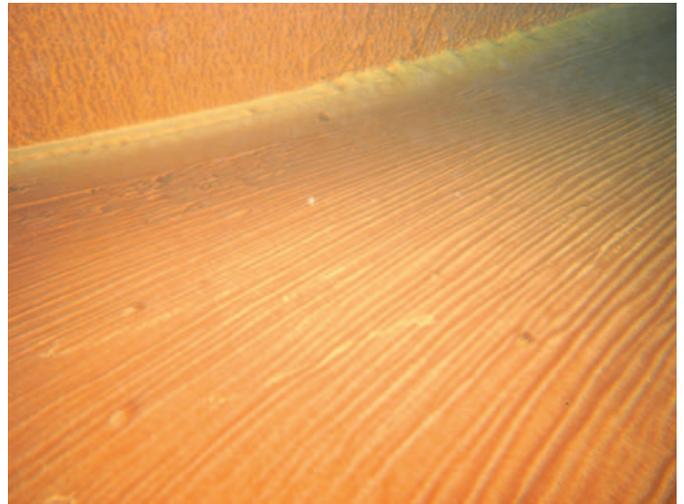
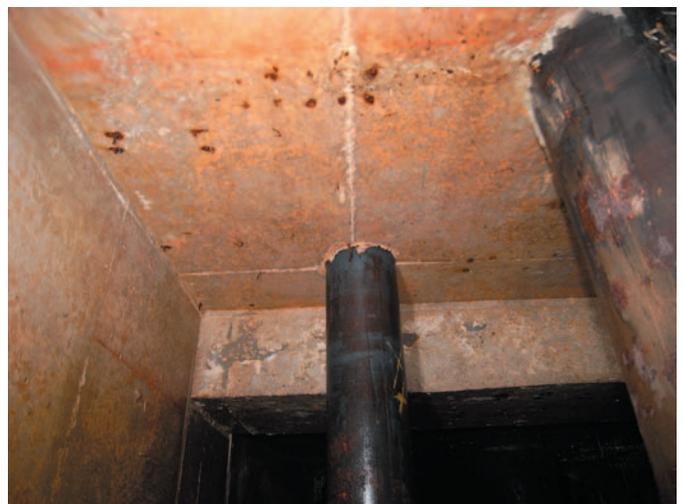
After removing all accumulated precipitate, these floor surfaces were inspected and found sound.

Heavy staining exists throughout all floor surfaces due to the accumulation of precipitate.

7 *Sound Floor Surfaces Found Stained After Cleaning*

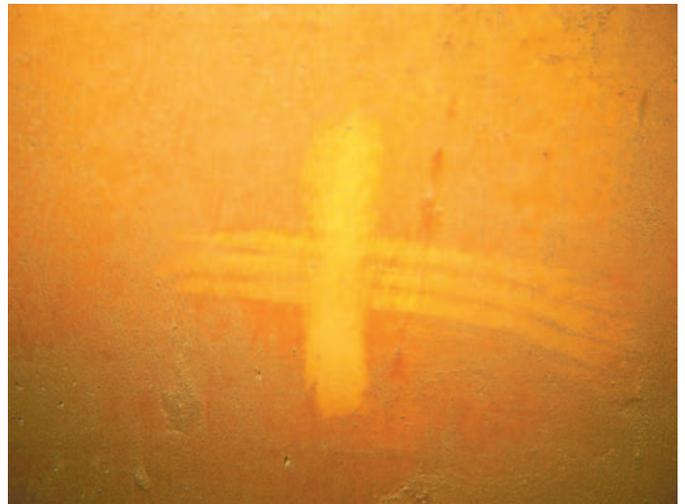
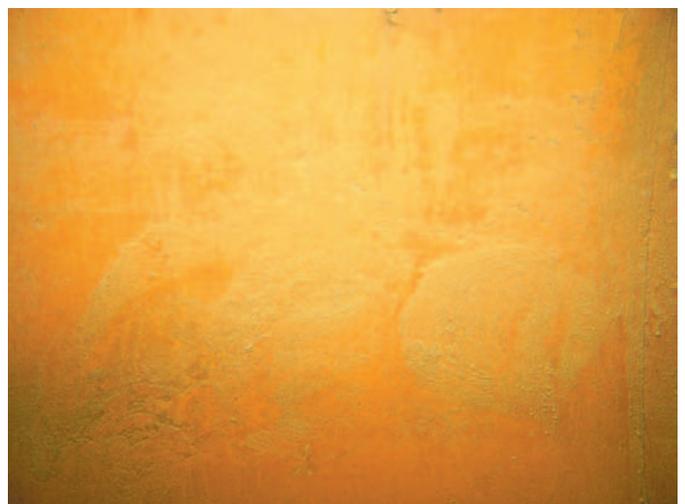
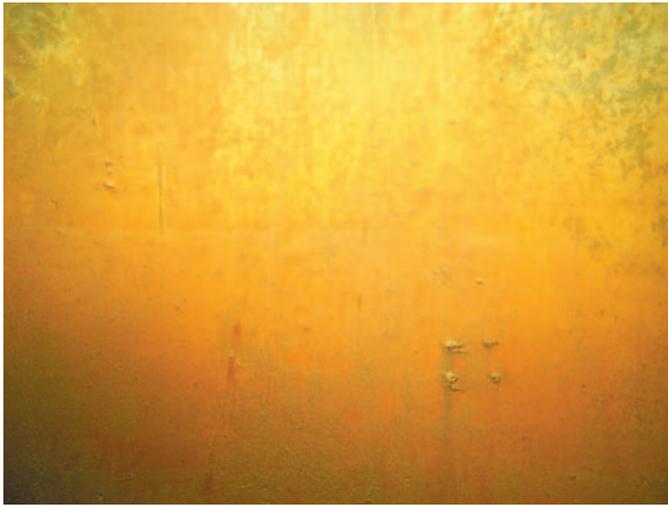
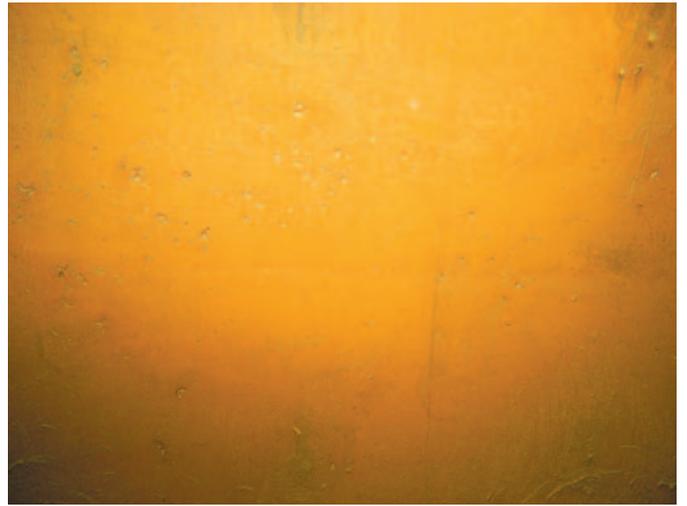
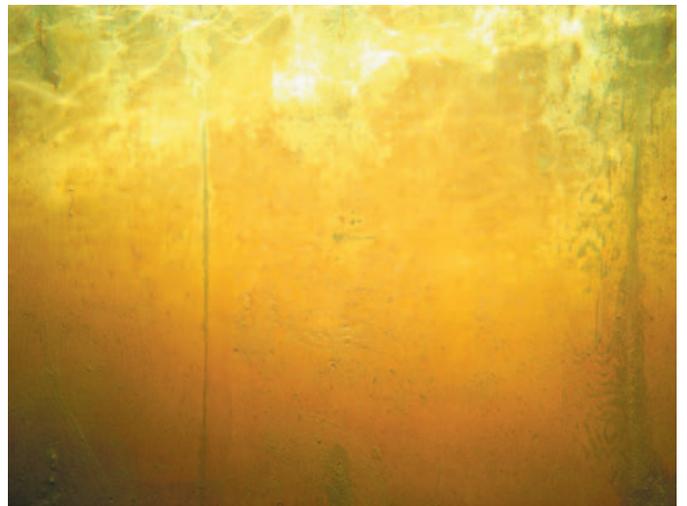
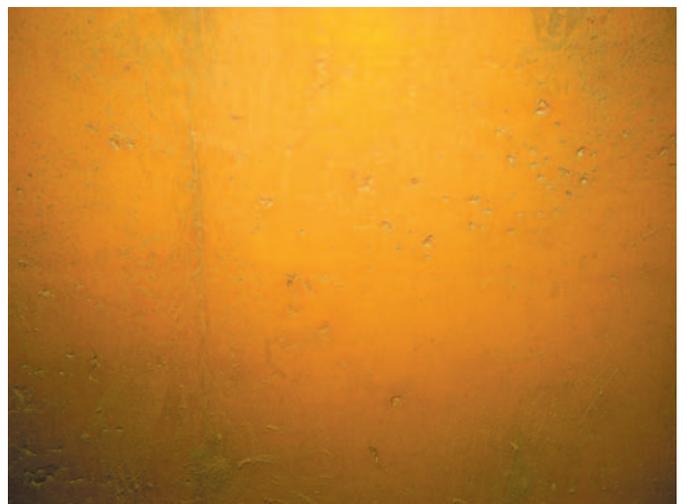
These interior walls appear very sound at this time, as no obvious cracks, spalls or other obvious fatigue of the concrete was seen at the time of this inspection.

Heavy staining exists on all wall surfaces beginning approximately 24" below the roof and wall junction, extending down to the floor.

26 *Sound Interior Walls Found With Heavy Staining*

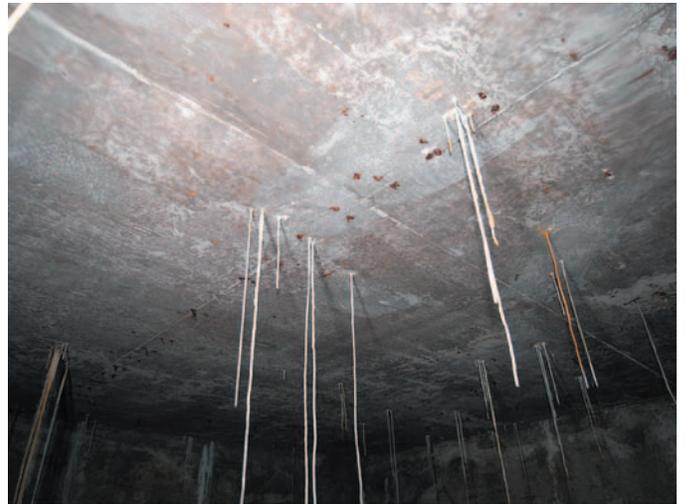
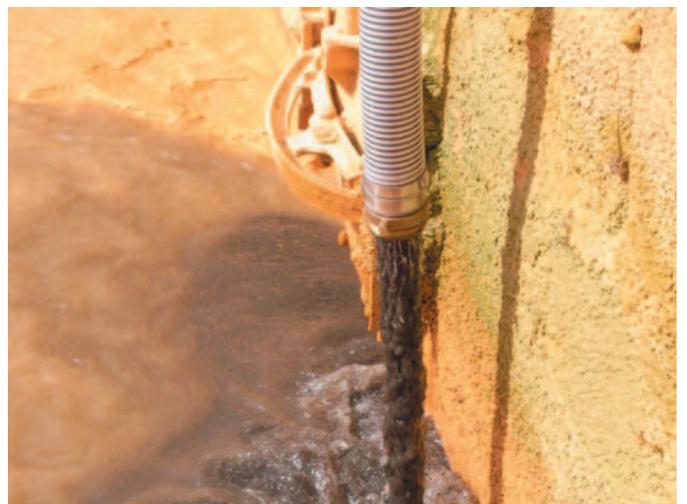
This formed in place, concrete overhead appears sound while no obvious fatigue was seen. Rust staining, appearing to be from construction hardware, was seen throughout the overhead.

Efflorescence and stalactites were seen throughout approximately 10% of the concrete overhead while no obvious failures of the concrete were found.

The rust staining witnessed throughout the overhead appears to be the result of construction hardware left within the concrete.

45 *Overhead Surfaces Found With Efflorescence, Stalactites And Rust Staining*
