On February 10, 2009, Underwater Solutions Inc. conducted an inspection of the 1.5-million gallon welded steel water storage tank to provide information regarding the overall condition and integrity of this structure and removed the sediment accumulation found on the floor of the structure.

On February 11, 2009, Underwater Solutions Inc. conducted an inspection of the 250,000-gallon concrete clearwell to provide information regarding the overall condition and integrity of this structure and removed the sediment accumulation found on the floor of the structure.

In 2007 the City prepared a report titled Winson Water Treatment Plant Expansion Feasibility Study indicating that the existing treatment systems and Biscayne Aquifer wellfield infrastructure were at or near the end of their useful life. Based upon subsequent on-site observations and discussions with City staff, H&S generally concurred with these recommendations. To this end, the City determined that WTP facilities should be rehabilitated via the Bid Package 3: WTP Rehabilitation Project proposes to ensure continued reliability through the year 2030. Due to budget constraints, the existing treatment capacity will remain fix

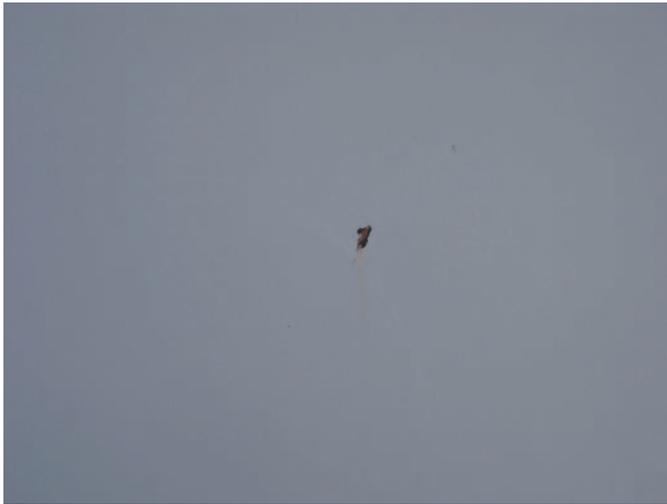
7 *Exterior Wall Surfaces Found With Coating Chips, Exposed Steel And Mild Surface Corrosion*

The exterior wall surfaces were inspected and found to appear sound while several coating chips, ranging from 1/8" to 3/4" in diameter, were found on approximately 5% of the walls throughout all elevations of the tank.

These coating chips appear to be the result of objects striking these surfaces and cause mild surface corrosion of the exposed steel.

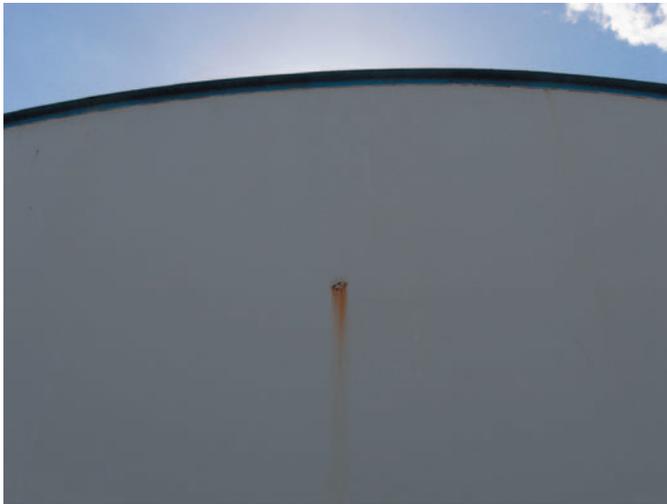
9 *Exterior Wall Surfaces Found With Coating Chips, Exposed Steel And Mild Surface Corrosion*

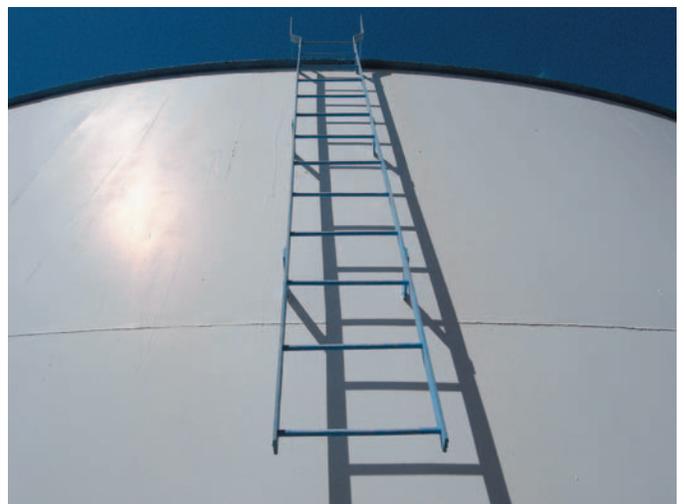
12 *Ladder*

This entire structure was found in good condition and provides good safe access to the roof at this time.

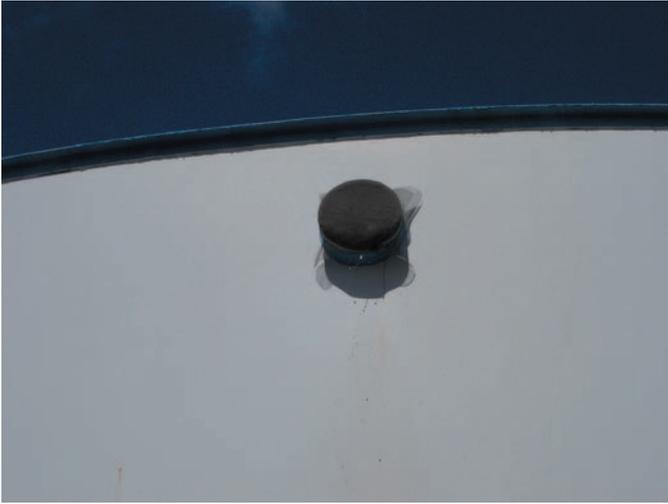
13 *Overflow*

This overflow pipe was found with a secure screen properly installed, yet several 2" diameter holes were seen within this screen.

This overflow was found unobstructed at the time of this inspection.

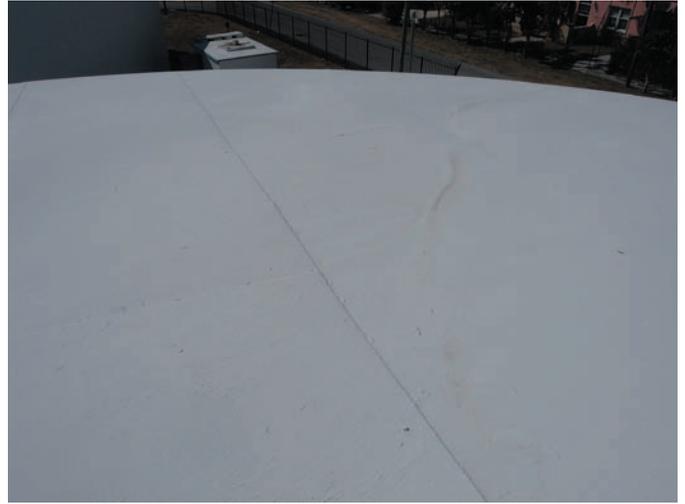
14 *Roof Surfaces Found With Coating Failure, Blotch Rusting And Exposed Steel*

The protective coating applied to these roof surfaces has become weathered, reducing the film thickness. This condition causes poor adhesion value, resulting in cracking of the coating and blotch rusting on approximately 10% of these surfaces.

Within all areas where the protective coating has cracked, exposure of the underlying steel was found, yet no obvious steel fatigue (pitting) was witnessed at the time of this inspection.

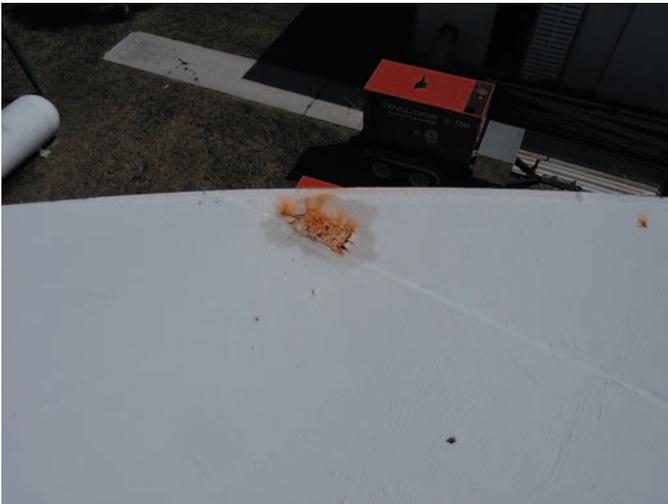
15 *Roof Surfaces Found With Coating Failure, Blotch Rusting And Exposed Steel*

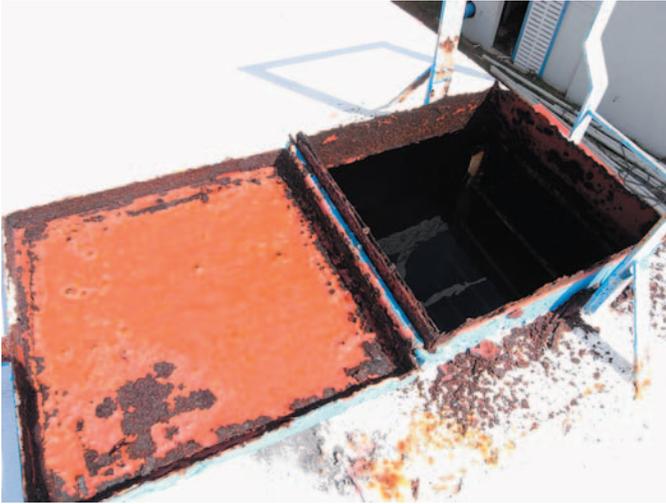
19 *Hatch Found With Metal Fatigue Of The Trunk*

The hatch lid was found in working condition, yet extensive fatigue of the steel has caused gaps and holes throughout the circumference of the hatch trunk, allowing access to the interior of the tank.

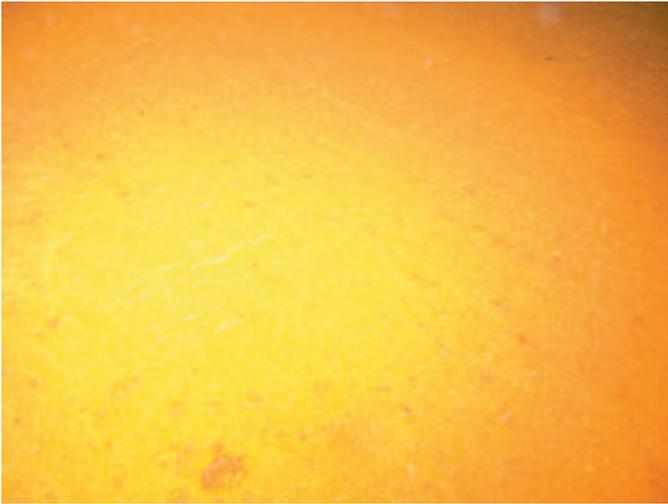
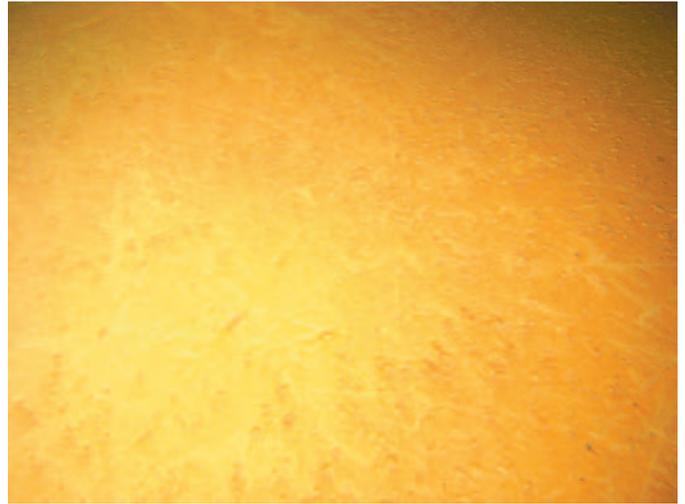
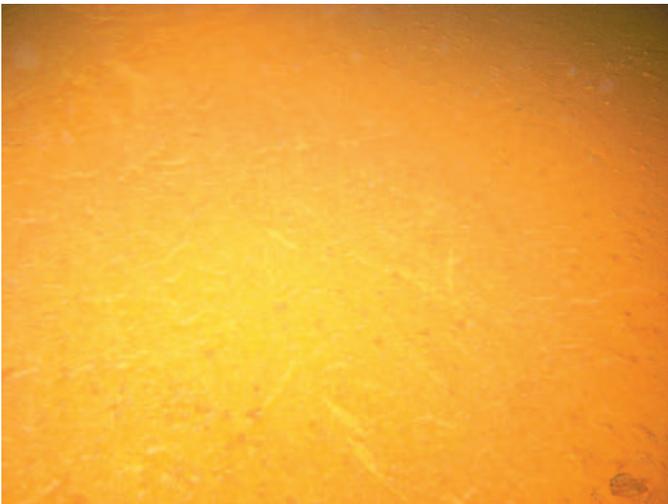
25 *Sound Floor Surfaces With Staining After Cleaning*

26 *Sound Floor Surfaces With Staining After Cleaning*

27 *Sound Floor Surfaces With Staining After Cleaning*

28 *Sound Floor Surfaces With Staining After Cleaning*

29 *Sound Floor Surfaces With Staining After Cleaning*

After removing all accumulated precipitate, these steel floor panel surfaces, to include the welds between each panel, were inspected and found with mostly sound conditions while coating failure exposes the primary coating system and the underlying steel in several areas.

The protective coating applied to these surfaces was found with adhesion loss causing blistering throughout approximately 5% of the floor surfaces.

Approximately 15% of these coating blisters have ruptured, causing exposure of the primary coating system and underlying steel, resulting in moderate surface corrosion.

Moderate staining exists throughout all floor surfaces due to the accumulation of precipitate.

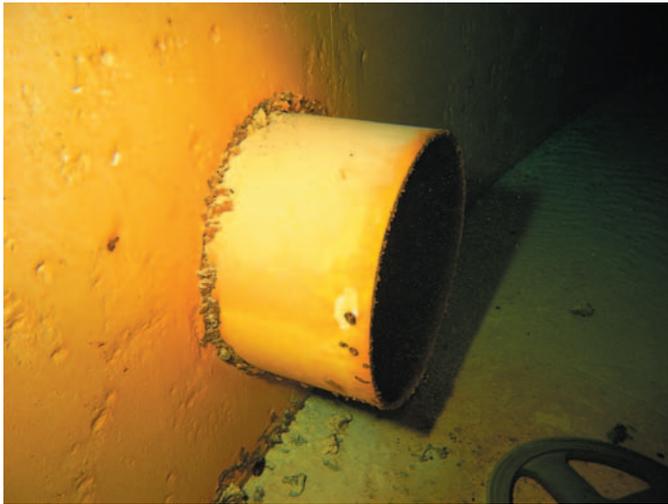
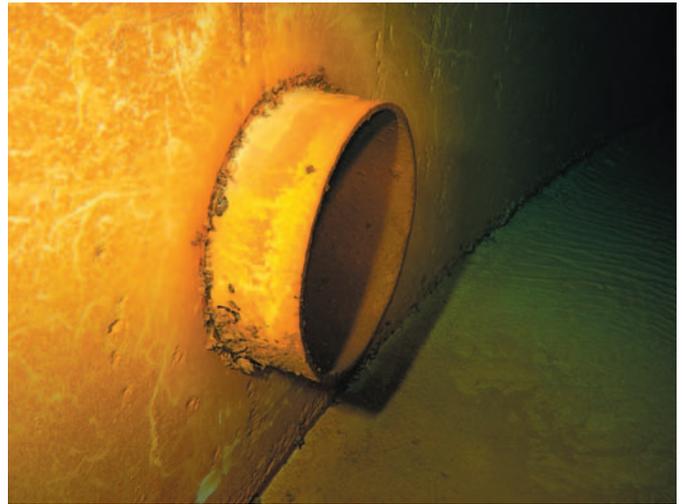
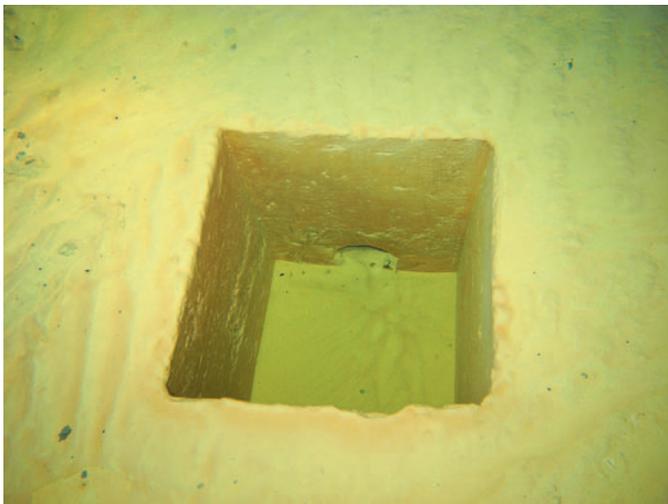
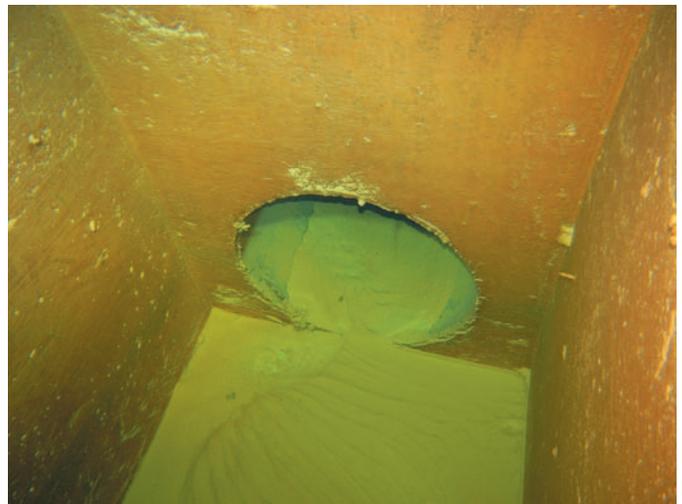
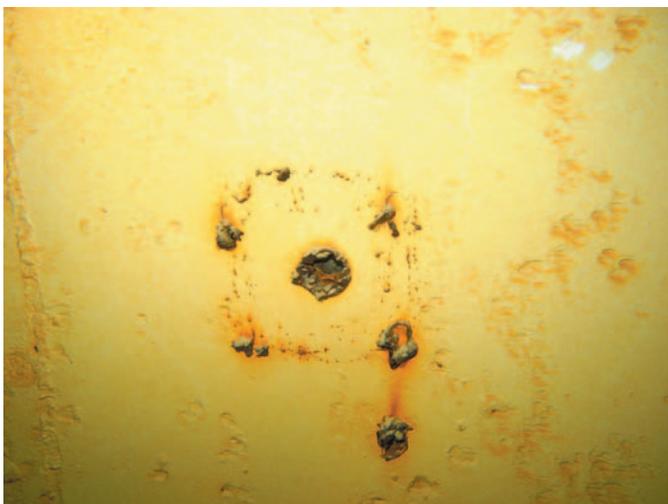
31 *Piping*

32 *Piping*

33 *Piping*

34 *Piping*

35 *Piping*

All piping was found without obstructions at the time of this inspection.

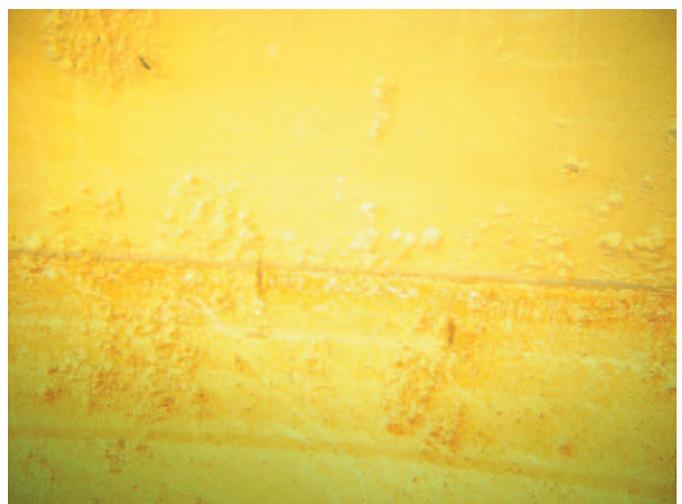
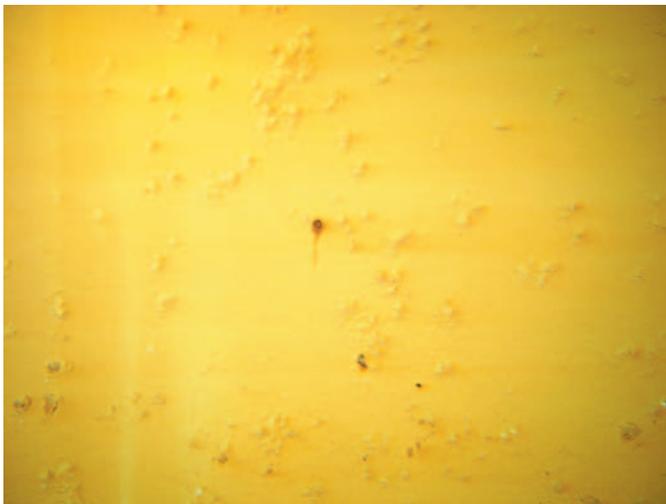
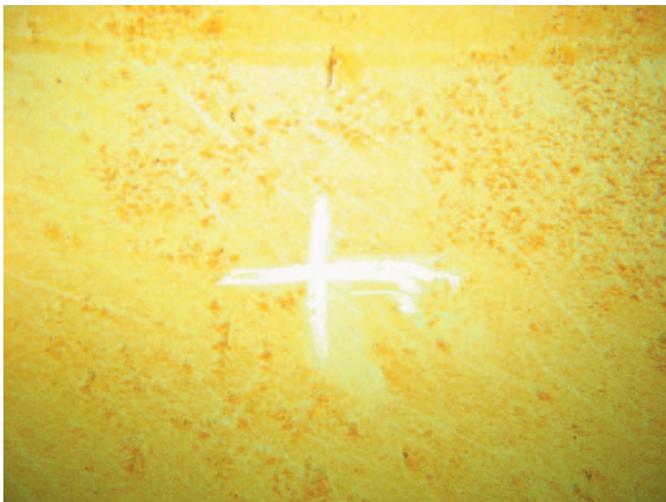
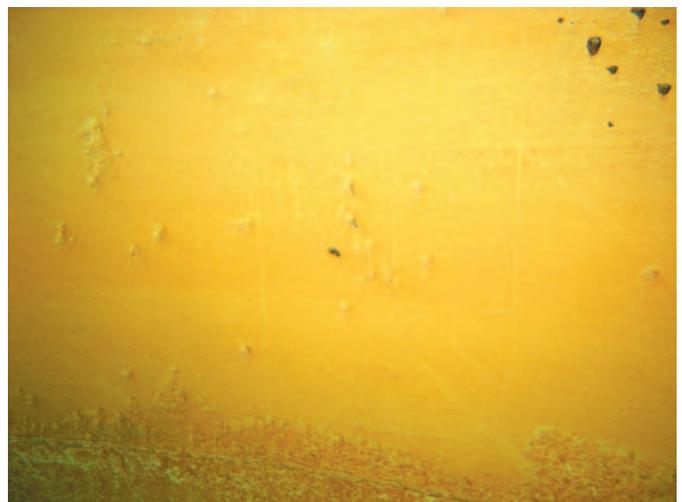
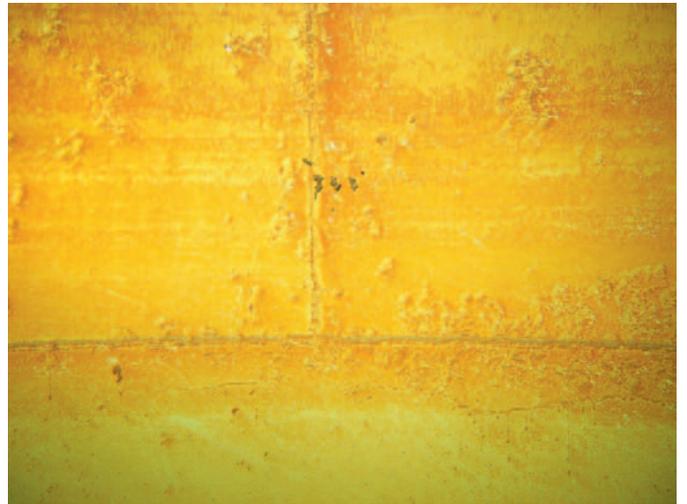
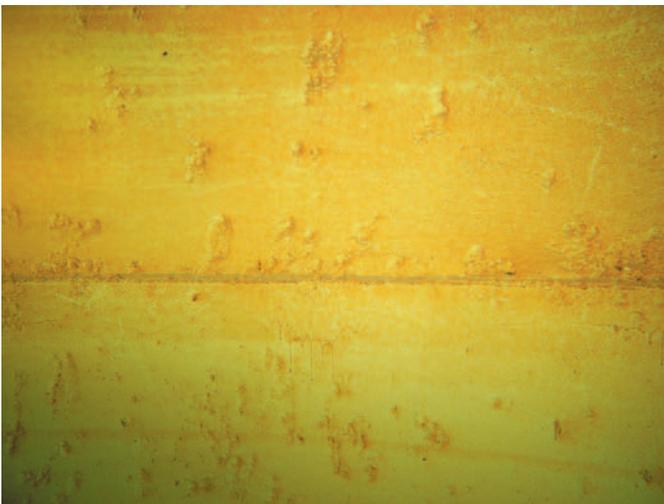
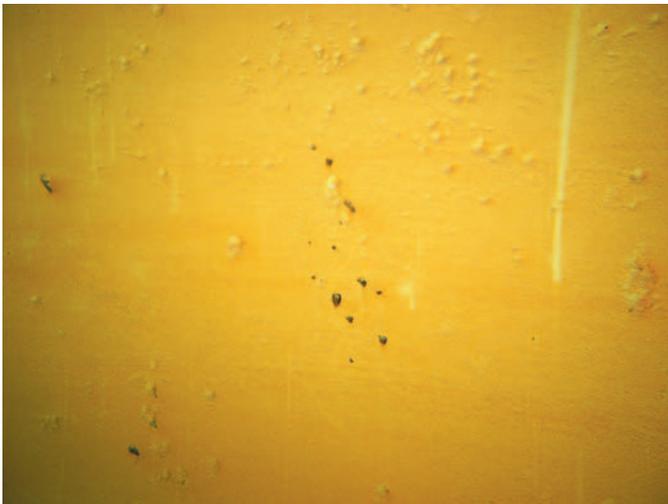
36 *Interior Wall Surfaces Found With Coating Failure, Exposed Steel And Surface Corrosion*

Coating blisters were found throughout approximately 5% of all wall panel surfaces, to include all welds between each panel, due to adhesion loss.

At the time of this inspection, none of the blisters had ruptured, as no exposure of the underlying steel was witnessed.

Heavy staining exists on all wall surfaces beginning approximately 10” below the overflow and extending down to the floor.

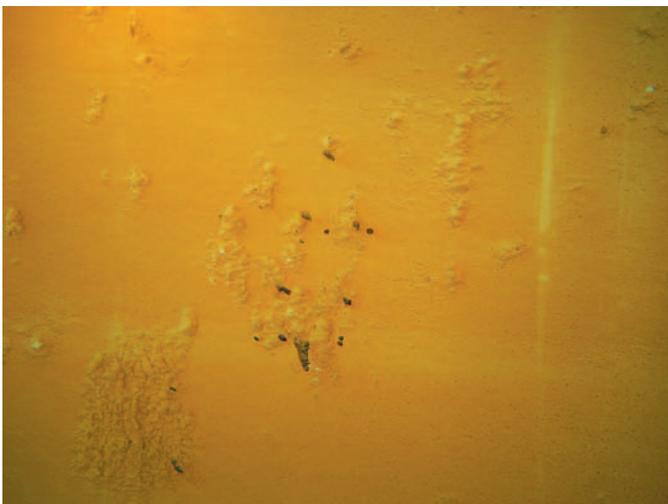
53 *Interior Wall Surfaces Found With Coating Failure, Exposed Steel And Surface Corrosion*

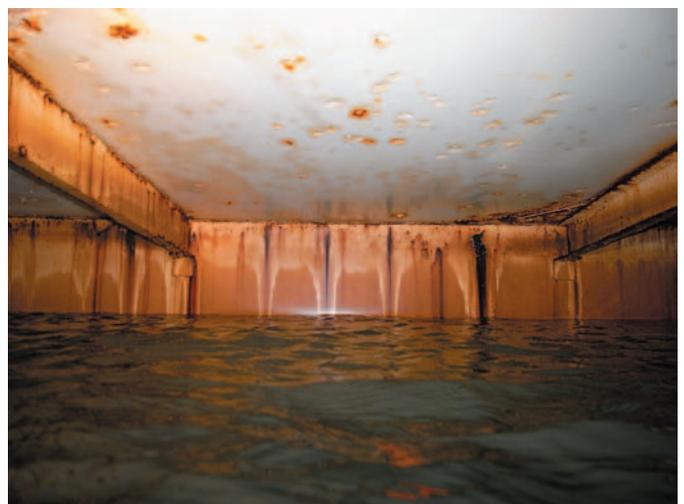
54 *Interior Wall Surfaces Found With Coating Failure, Exposed Steel And Surface Corrosion*

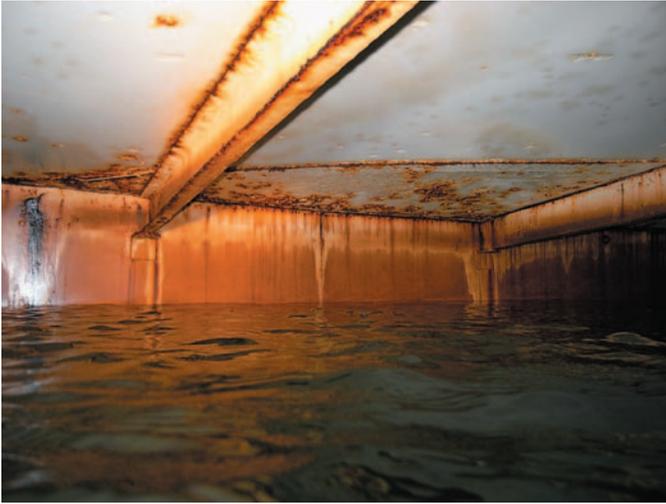
55 *Interior Wall Surfaces Found With Coating Failure, Exposed Steel And Surface Corrosion*

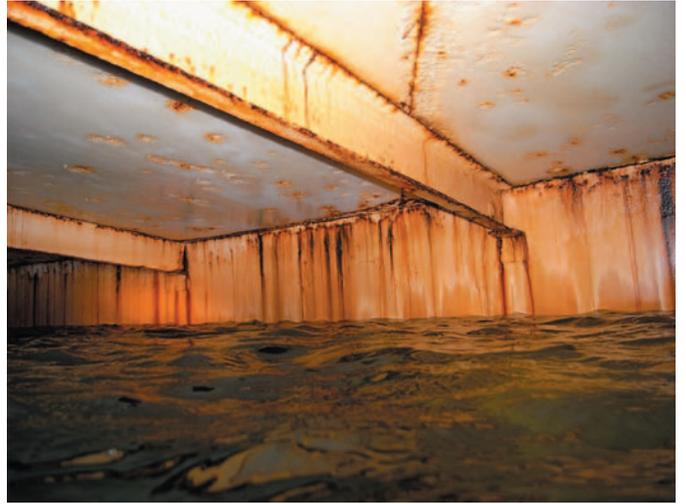
56 *Interior Wall Surfaces Found With Coating Failure, Exposed Steel And Surface Corrosion*

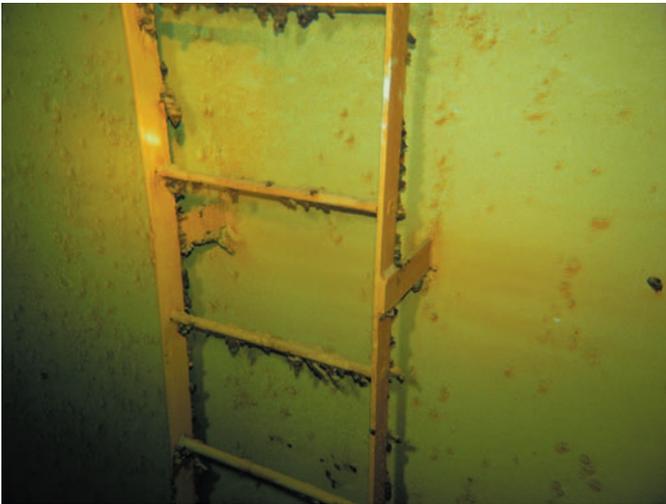
57 *Interior Ladder*

Although this ladder was found securely attached to the wall, the top three rungs have extensive fatigue of the steel resulting in failure and instability.

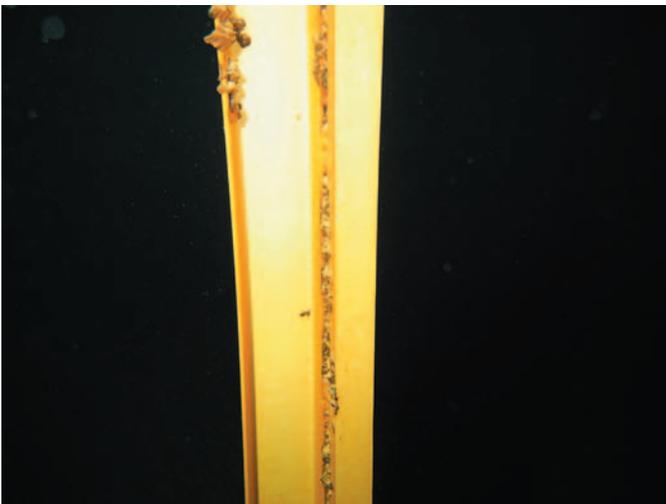
59 *One Of Seven Support Columns Found With Coating Failure, Exposed Steel And Surface Corrosion*

Each column appears sound while the protective coating has failed throughout all elevations of these columns resulting in exposure of the steel causing moderate surface corrosion.

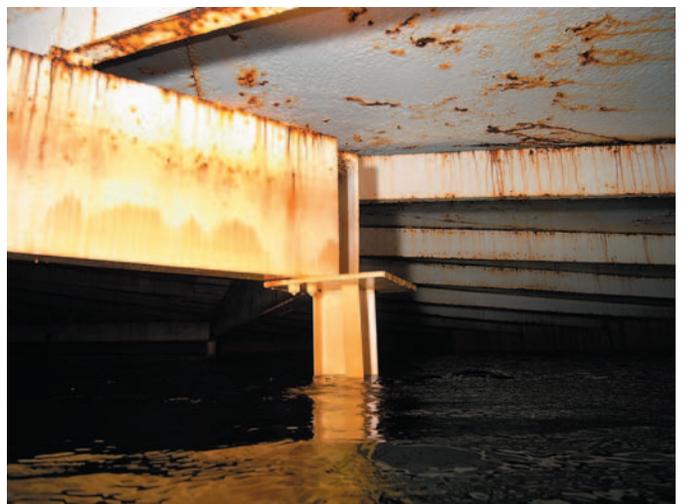
60 *One Of Seven Support Columns Found With Coating Failure, Exposed Steel And Surface Corrosion*

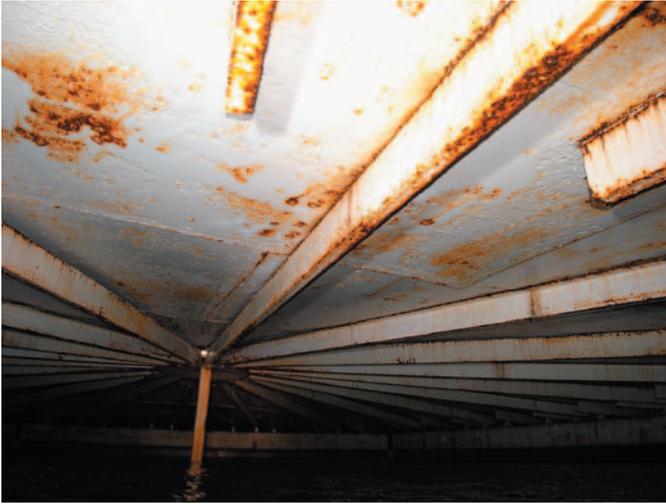
61 *Overhead Surfaces Found With Coating Failure And Surface Corrosion*

The protective coating applied to these overhead surfaces, to include all supports, appears to have poor adhesion value due to reduced film thickness and expiration. This condition causes blotch rusting to show through the coating throughout approximately 50% of these surfaces at this time.

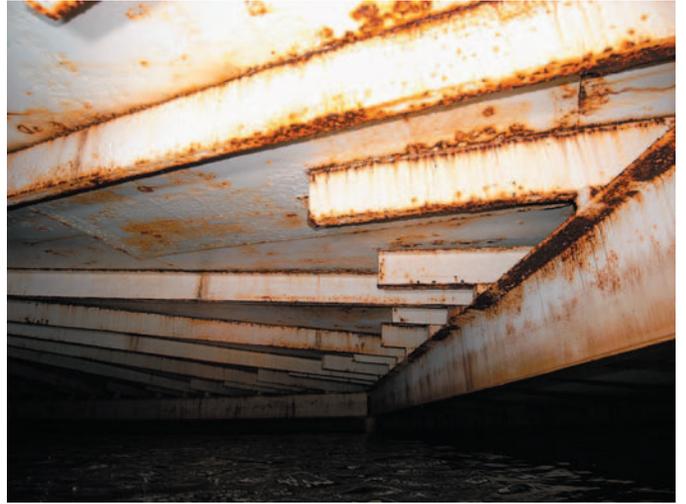
62 *Overhead Surfaces Found With Coating Failure And Surface Corrosion*

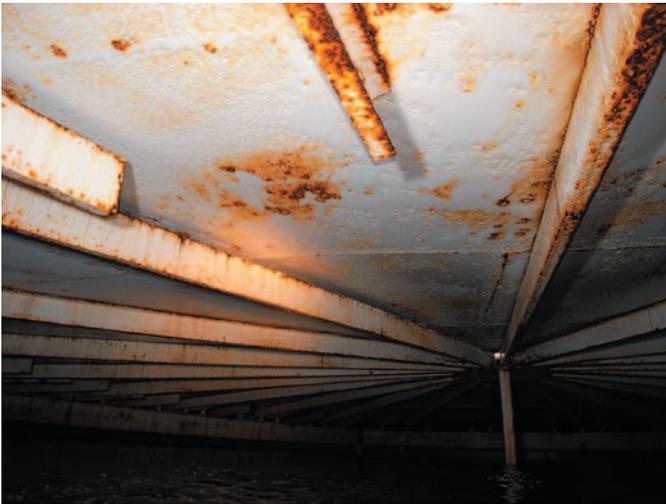
63 *Overhead Surfaces Found With Coating Failure And Surface Corrosion*

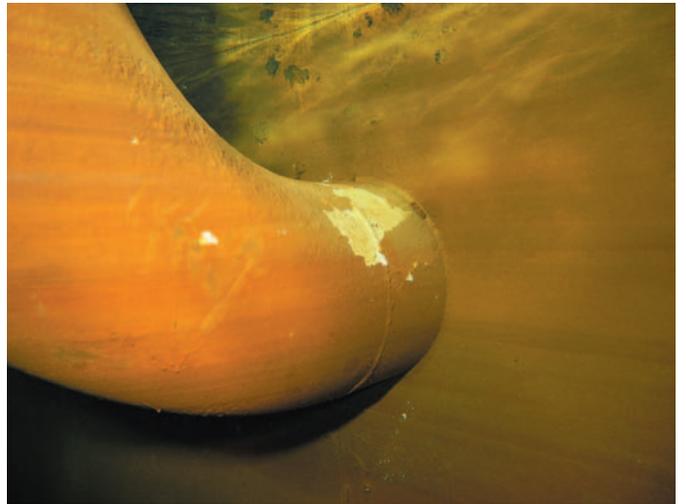
64 *Overflow Found Unobstructed*

This overflow was found without obstructions at the time of this inspection.

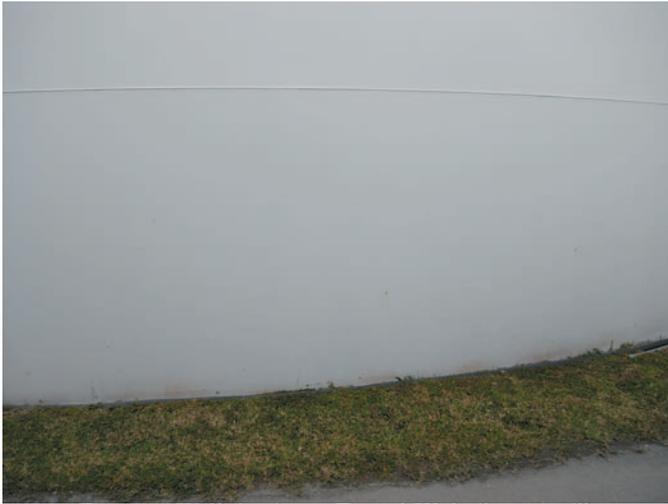
1 *Exterior Wall Surfaces Found With Coating Chips, Exposed Steel And Mild Corrosion*

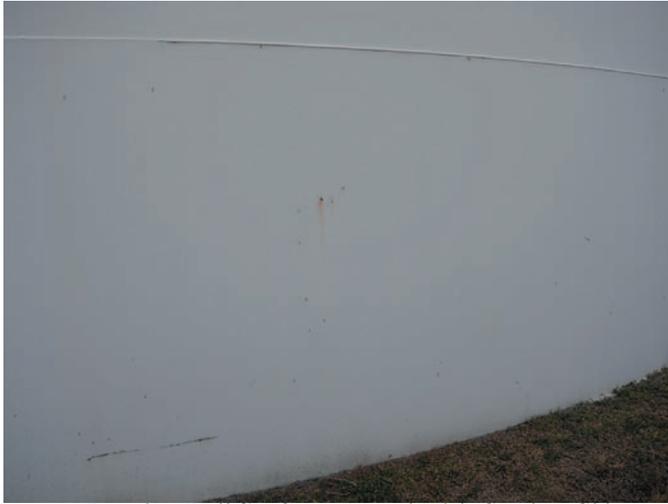
3 *Exterior Wall Surfaces Found With Coating Chips, Exposed Steel And Mild Corrosion*

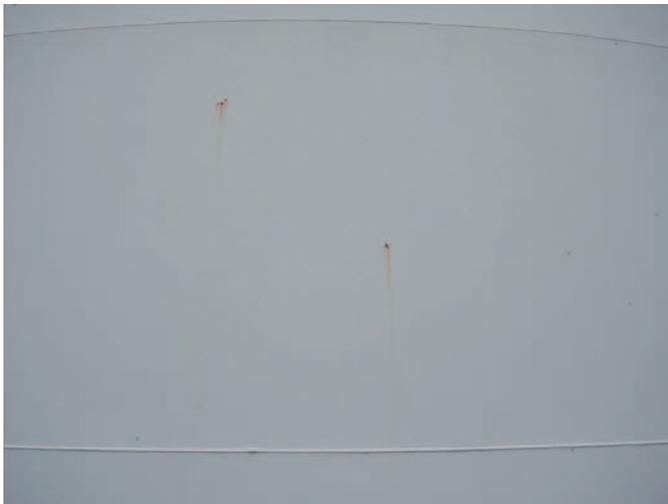
5 *Exterior Wall Surfaces Found With Coating Chips, Exposed Steel And Mild Corrosion*

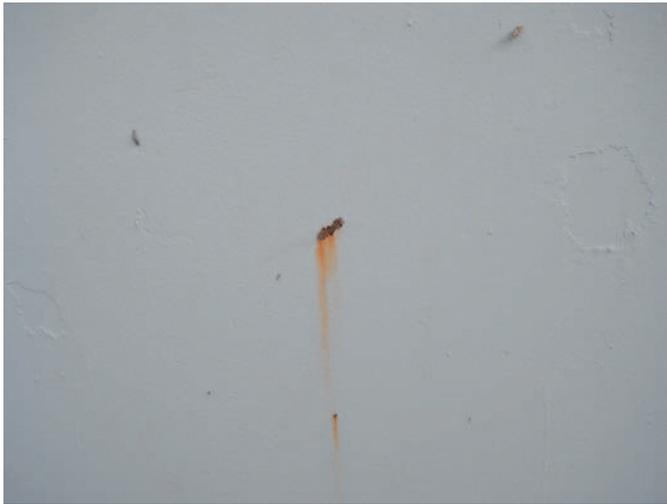
7 *Exterior Wall Surfaces Found With Coating Chips, Exposed Steel And Mild Corrosion*

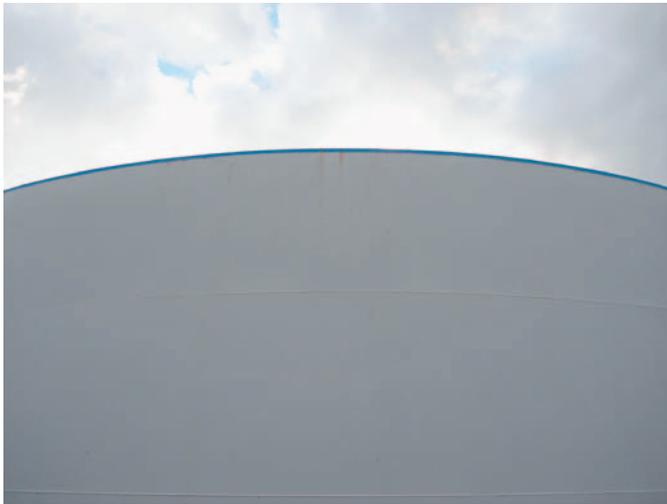
9 *Exterior Wall Surfaces Found With Coating Chips, Exposed Steel And Mild Corrosion*

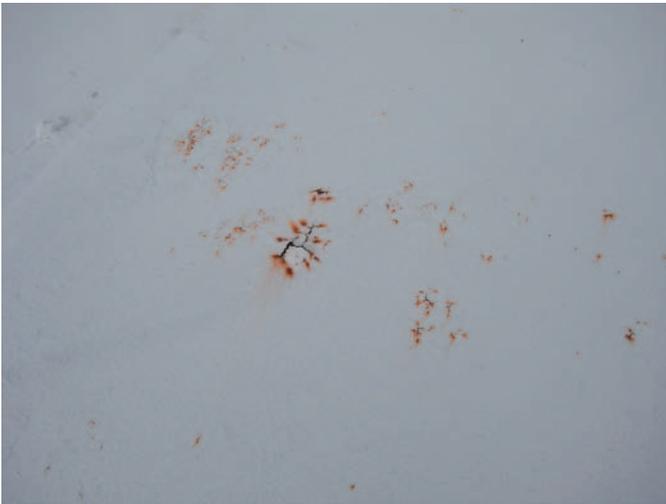
15 *Roof Surfaces Found With Coating Failure, Exposed Steel And Surface Corrosion*

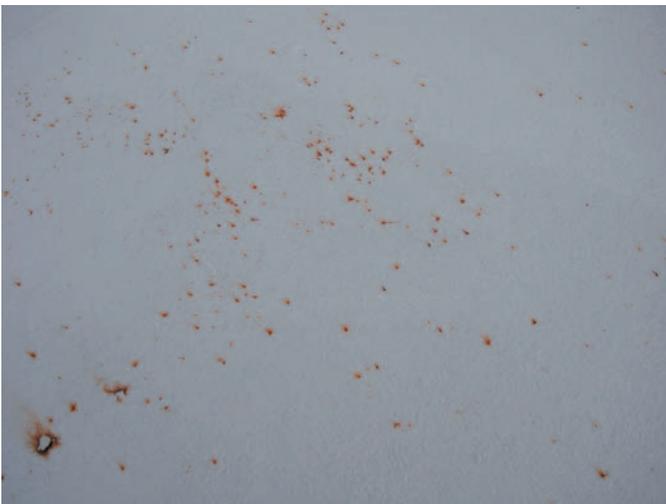
17 *Roof Surfaces Found With Coating Failure, Exposed Steel And Surface Corrosion*

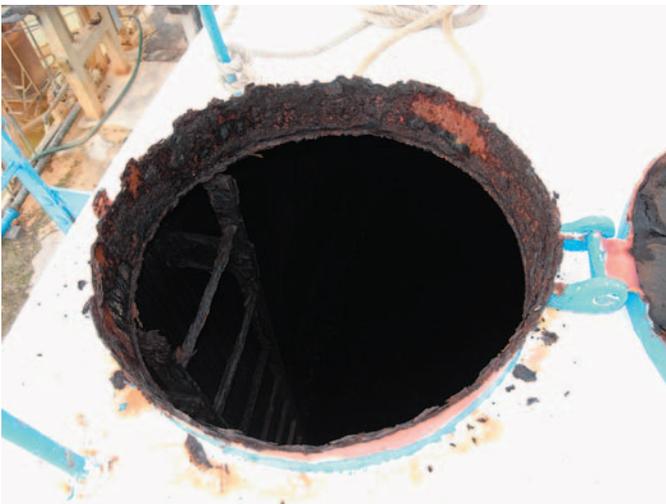
The trunk for the hatch was found with extensive fatigue of the steel, resulting in gaps and holes, allowing access to the tank interior when the lid is closed.

21 *Hatch Having Failure Of Steel Trunk*

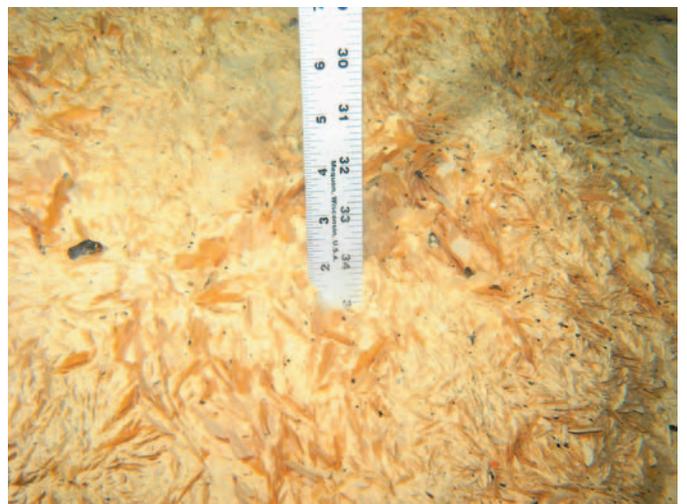
A non-uniform layer of accumulated precipitate was found on all floor surfaces averaging 2" in depth.

23 *Layer Of Precipitate*

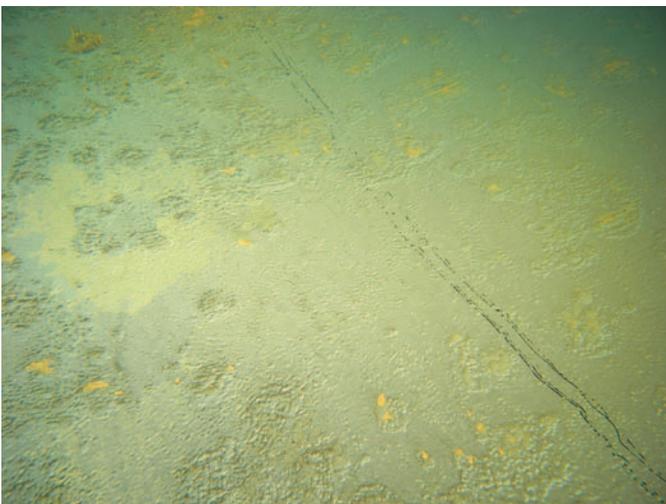
27 *Floor Surfaces Found With Coating Failure And Surface Corrosion After Cleaning*

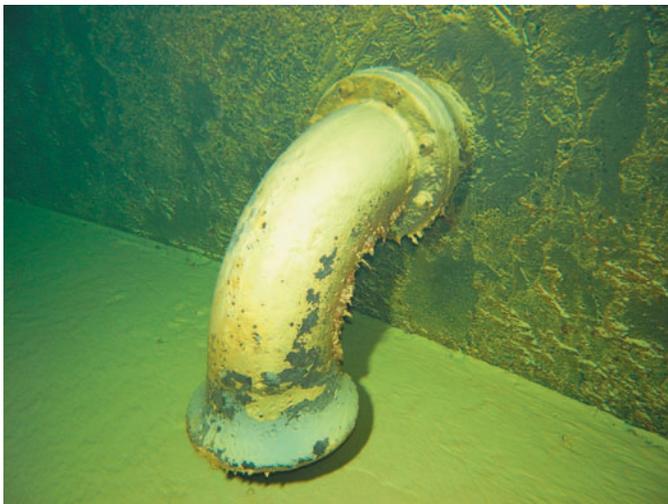
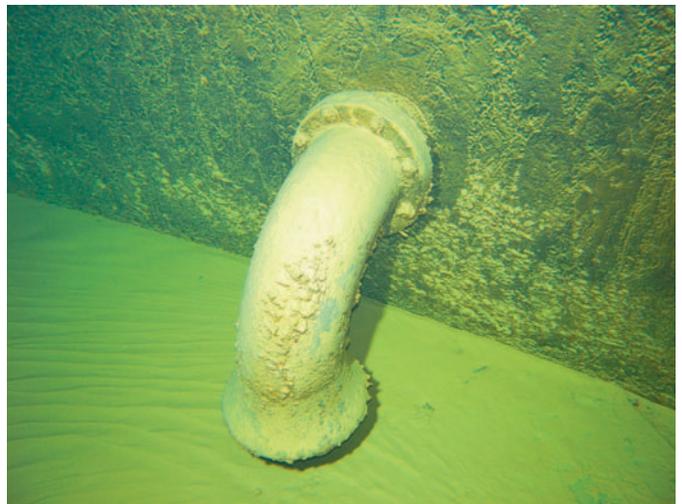
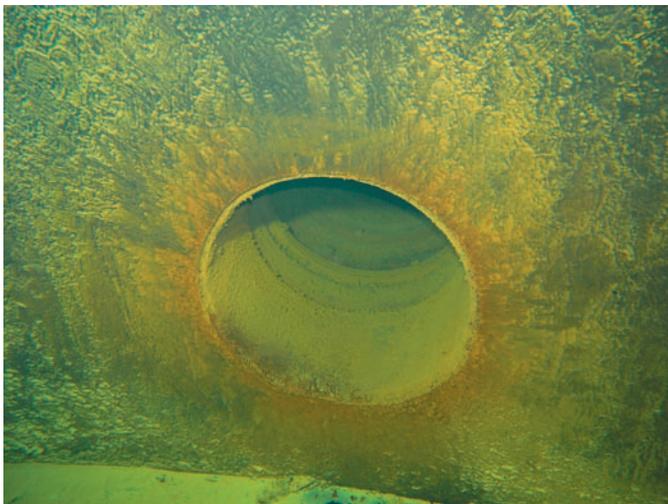
33 *Piping*

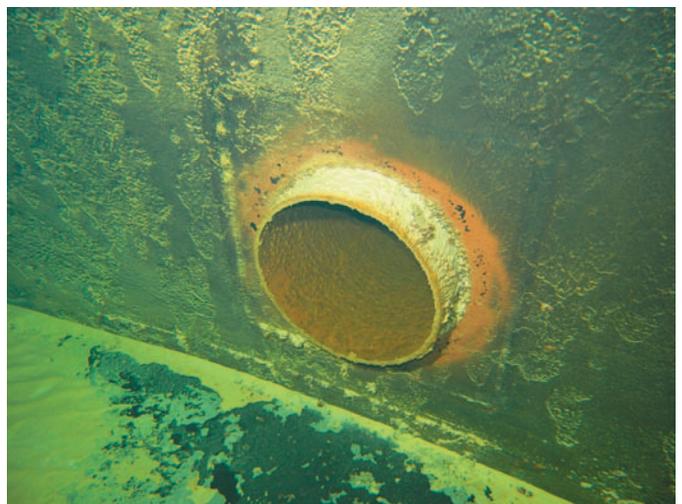
36 *Piping*

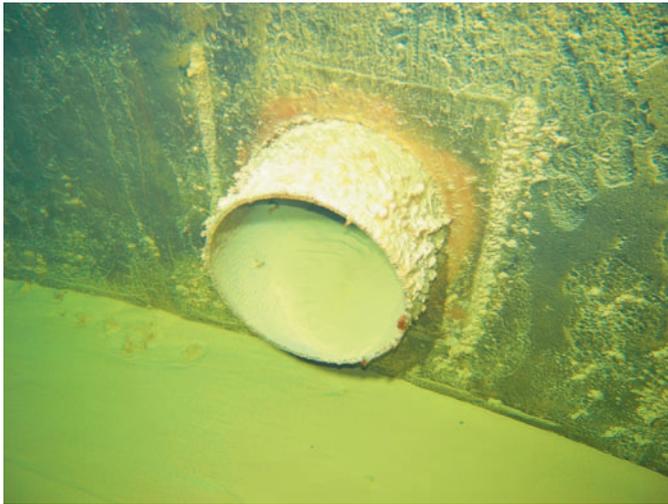
37 *Piping*

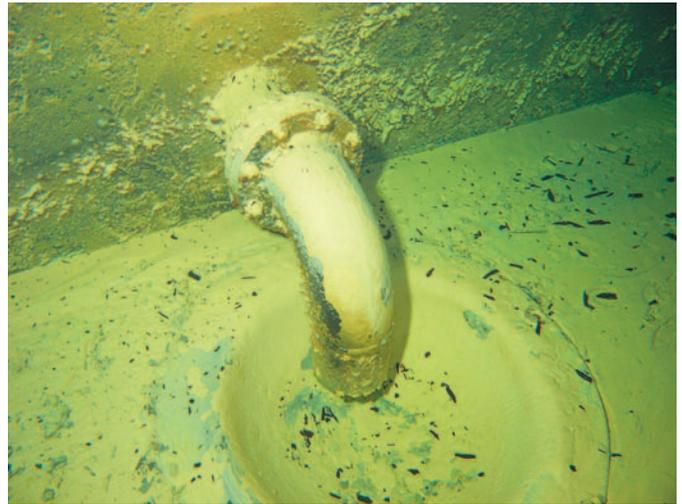
38 *Piping*

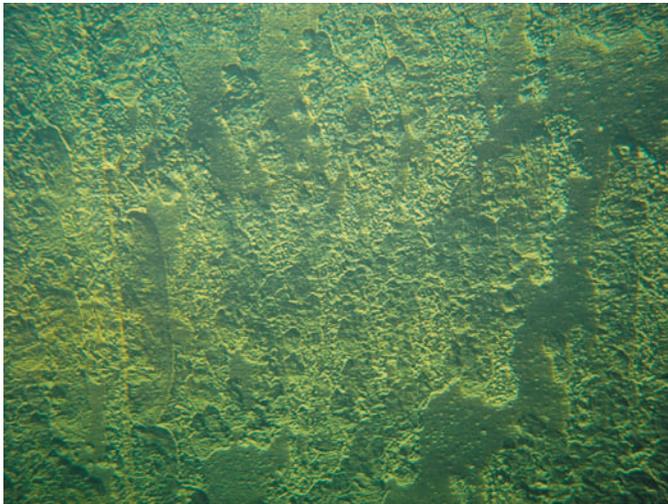
45 *Interior Wall Surfaces Found With Coating Failure And Staining*

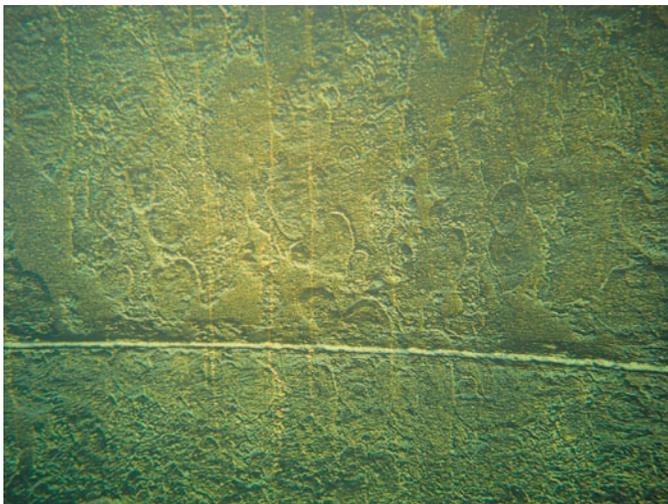
47 *Interior Wall Surfaces Found With Coating Failure And Staining*

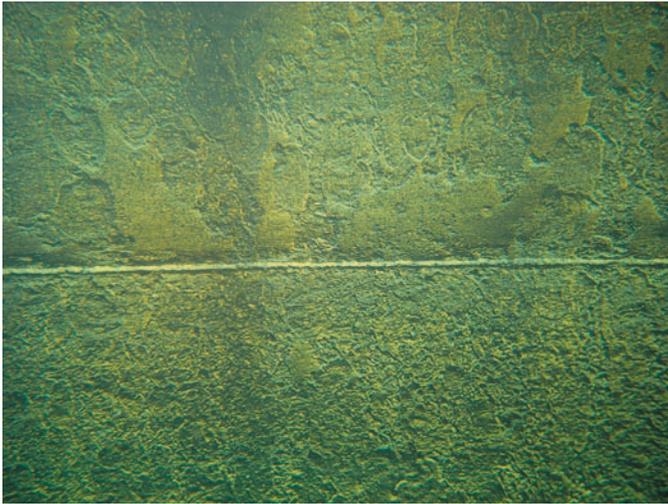
49 *Interior Wall Surfaces Found With Coating Failure And Staining*

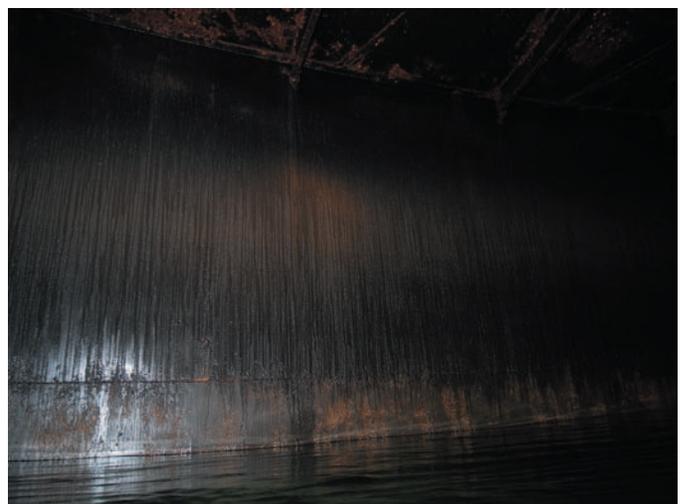
54 *Interior Wall Surfaces Found With Coating Failure And Staining*

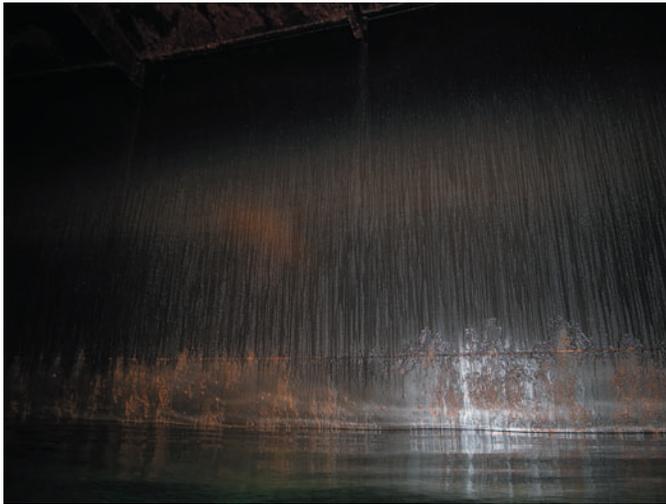
55 *Interior Wall Surfaces Found With Coating Failure And Staining*

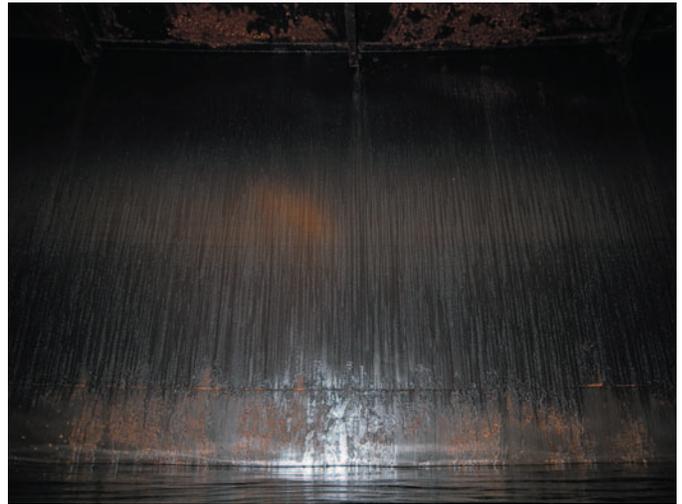
56 *Interior Wall Surfaces Found With Coating Failure And Staining*

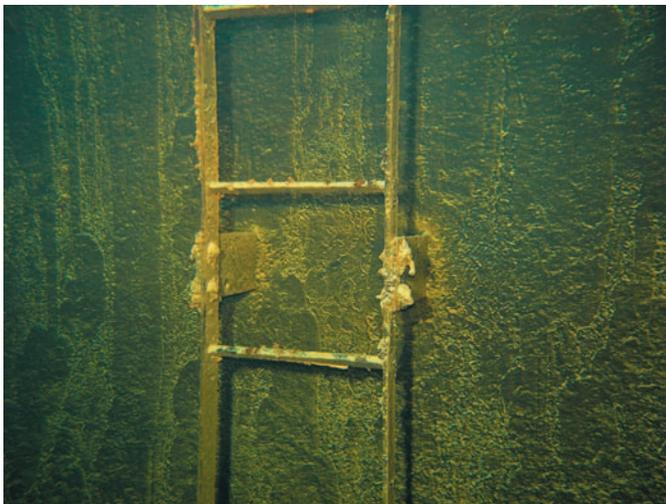
57 *Interior Ladder*

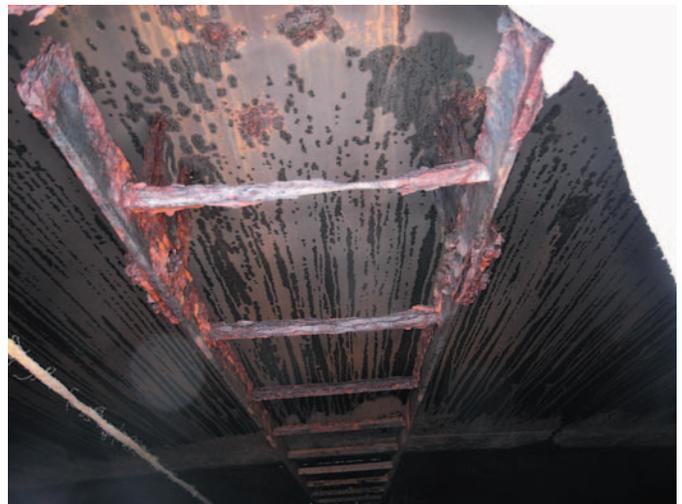
58 *Top Three Rungs Of Ladder Having Extensive Fatigue Of The Steel*

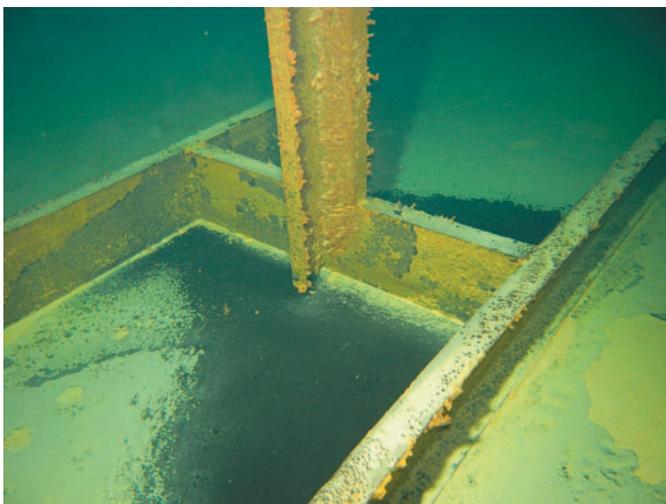
59 *One Of Three Support Column Found With Coating Failure, Exposed Steel And Corrosion*

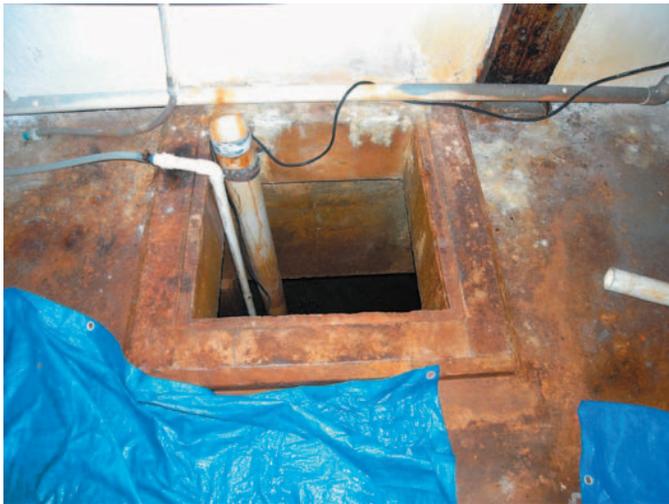
A metal grate was found securely in place over the hatch preventing unwanted access.

1 *Hatch*

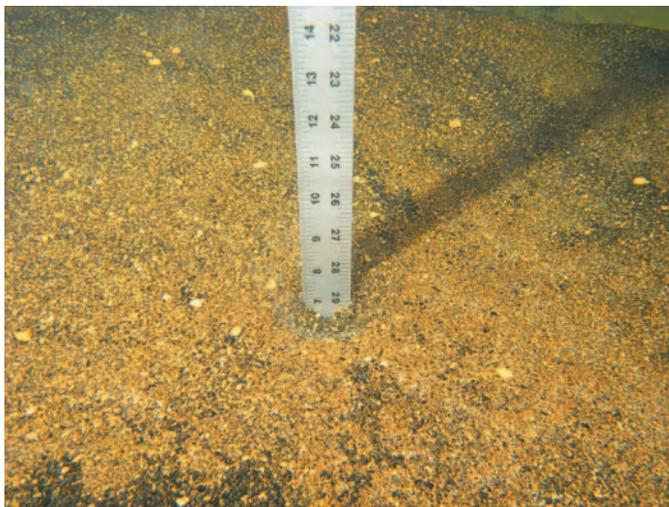
A uniform layer of accumulated precipitate was found on all floor surfaces averaging 6" in depth.

3 *Layer Of Precipitate*

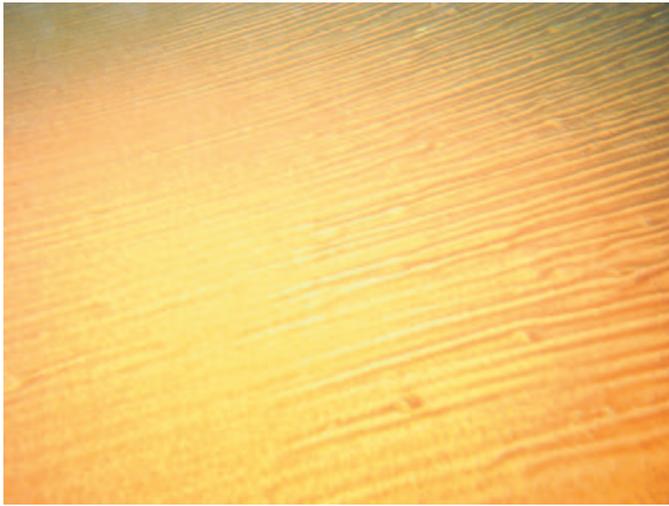
All floor surfaces are uniform as no cracks, spall or settlement were seen at the time of this inspection.

Heavy staining exists throughout all floor surfaces due to the accumulation of precipitate.

7 *Sound Floor Surfaces Found Stained After Cleaning*
