On February 10, 2009, Underwater Solutions Inc. conducted an inspection of the 1.5-million gallon welded steel water storage tank to provide information regarding the overall condition and integrity of this structure and removed the sediment accumulation found on the floor of the structure.

On February 11, 2009, Underwater Solutions Inc. conducted an inspection of the 250,000-gallon concrete clearwell to provide information regarding the overall condition and integrity of this structure and removed the sediment accumulation found on the floor of the structure.

In 2007 the City prepared a report titled Winson Water Treatment Plant Expansion Feasibility Study indicating that the existing treatment systems and Biscayne Aquifer wellfield infrastructure were at or near the end of their useful life. Based upon subsequent on-site observations and discussions with City staff, H&S generally concurred with these recommendations. To this end, the City determined that WTP facilities should be rehabilitated via the Bid Package 3: WTP Rehabilitation Project proposes to ensure continued reliability through the year 2030. Due to budget constraints, the existing treatment capacity will remain fix

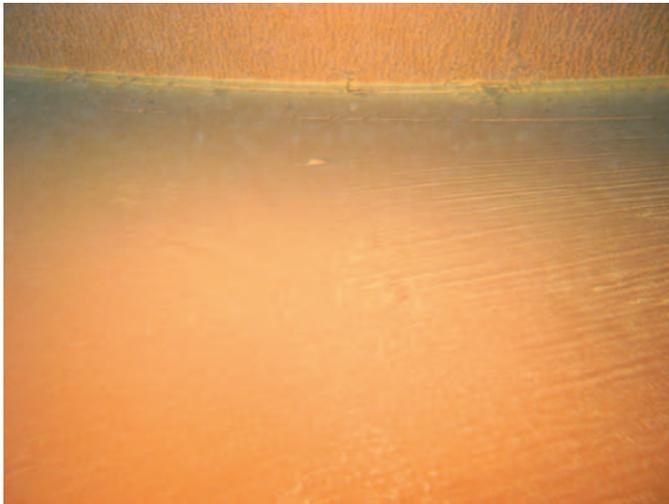
All floor surfaces are uniform as no cracks, spall or settlement were seen at the time of this inspection.

Heavy staining exists throughout all floor surfaces due to the accumulation of precipitate.

9 *Sound Floor Surfaces Found Stained After Cleaning*

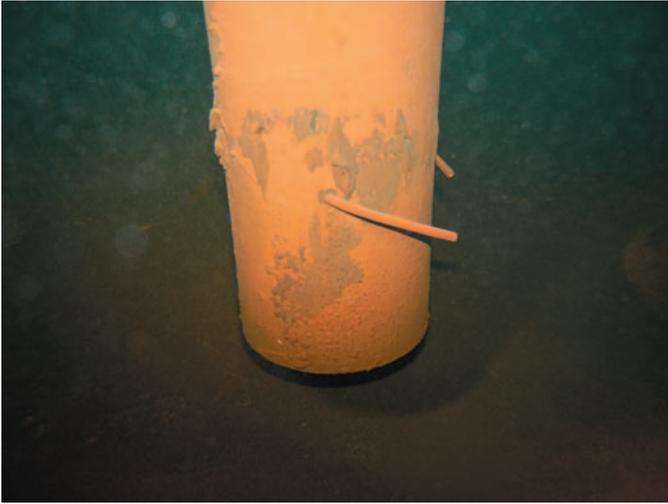
All piping was found without obstructions at the time of this inspection.

13 *Piping*

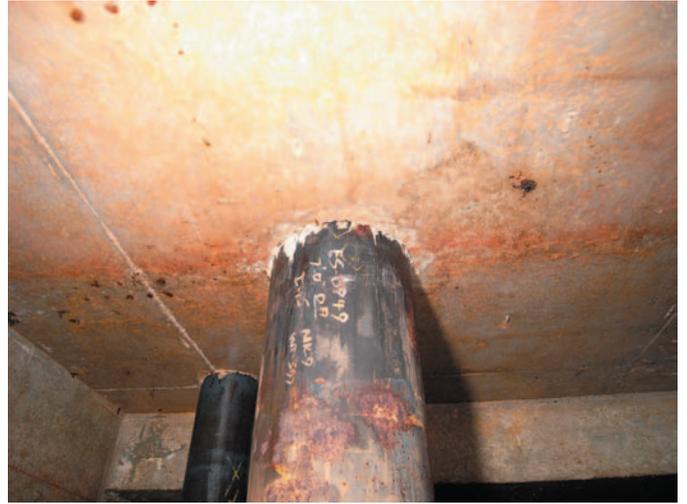
14 *Piping*

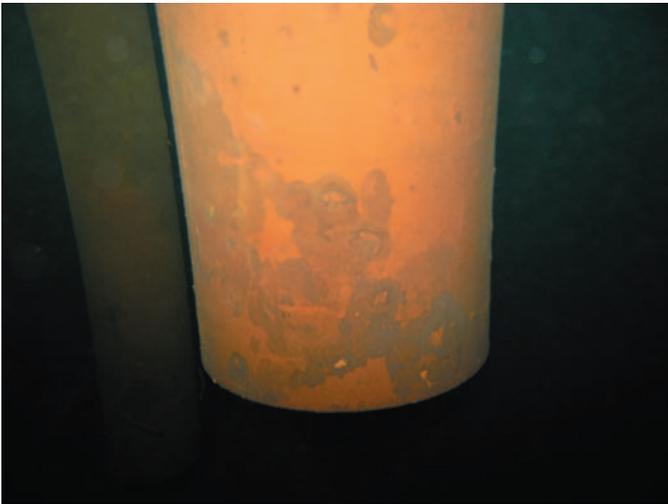
15 *Piping*

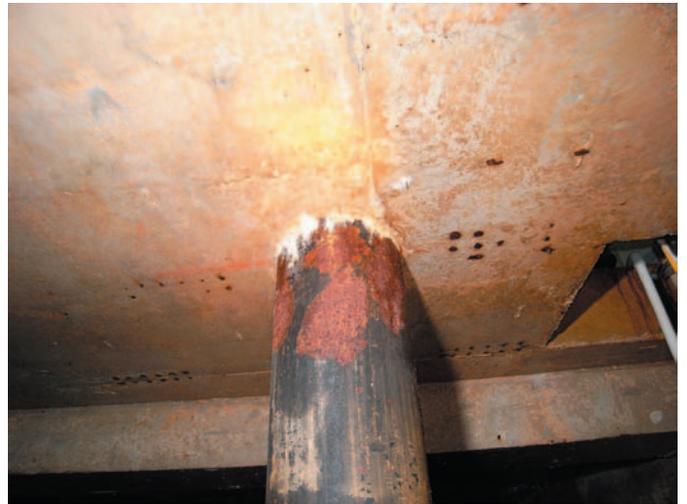
16 *Piping*

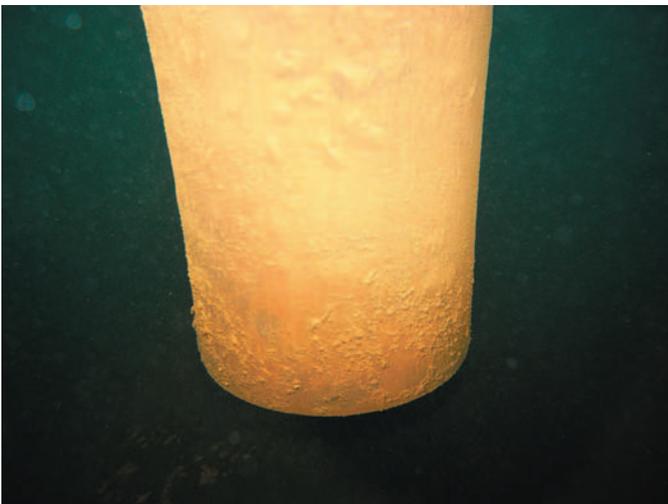
17 *Piping*

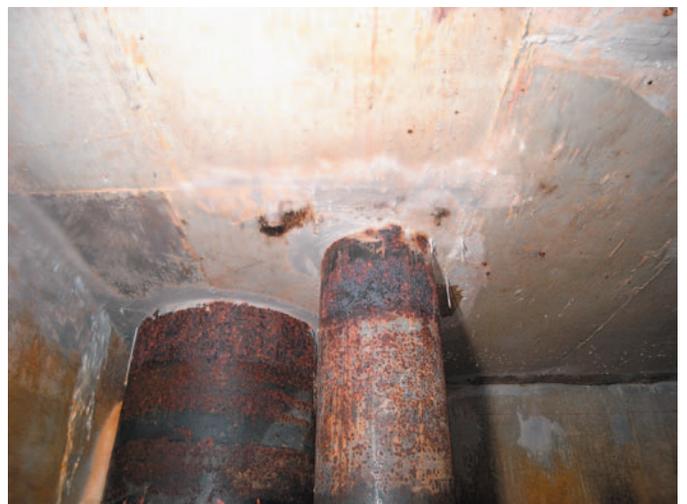
18 *Piping*

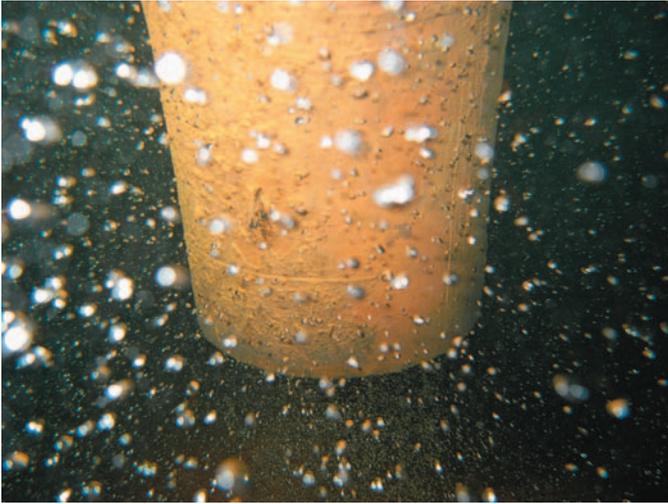
19 *Piping*

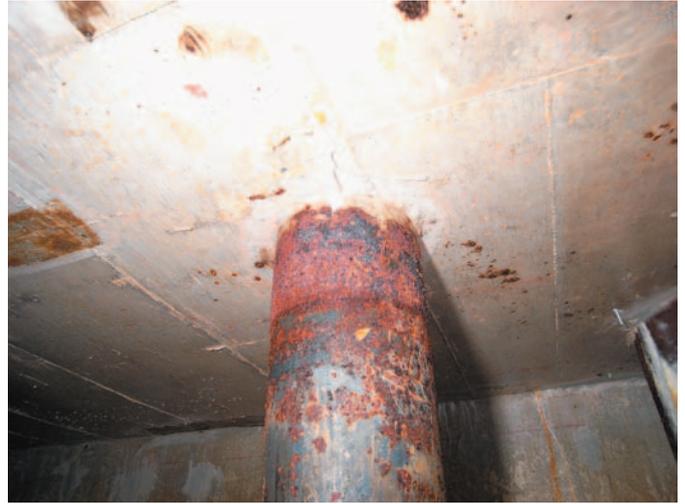
20 *Piping*

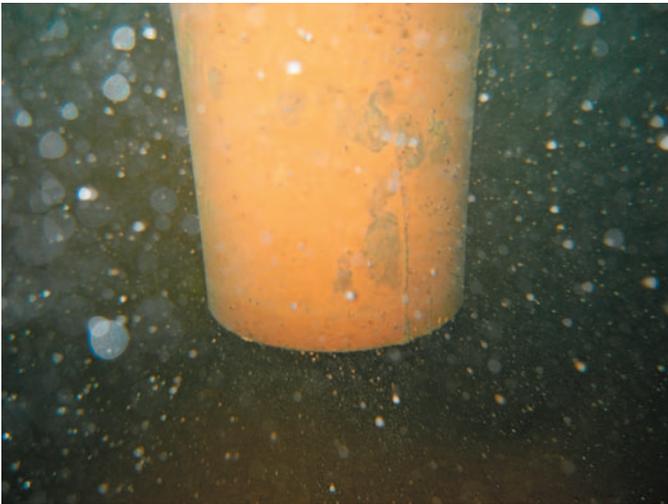
21 *Piping*

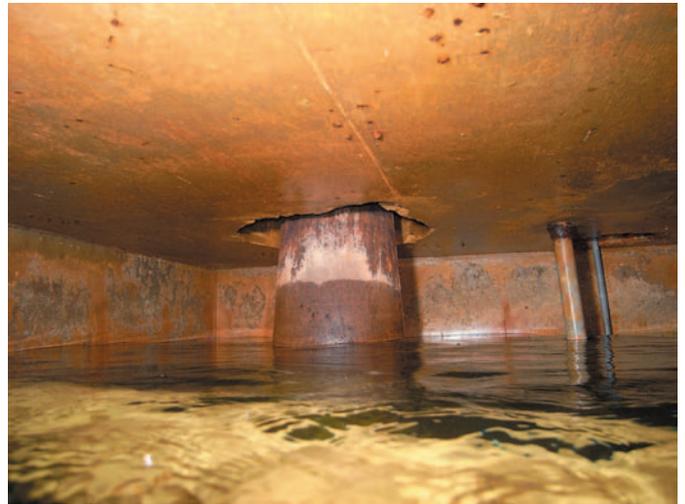
22 *Pump Column Found Unobstructed*

- ◆ No obstructions or failures in the pumps or any of the piping.

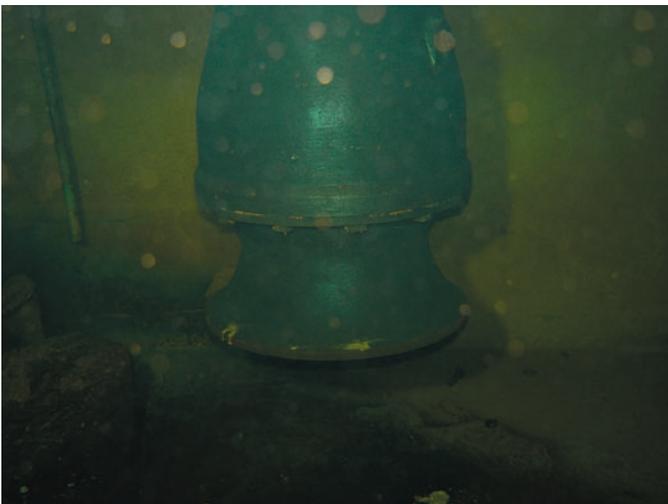
23 *Pump Column Found Unobstructed*

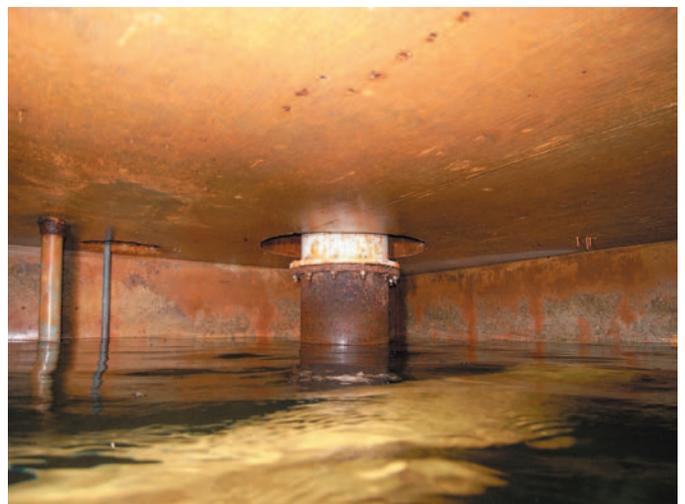
24 *Pump Column Found Unobstructed*

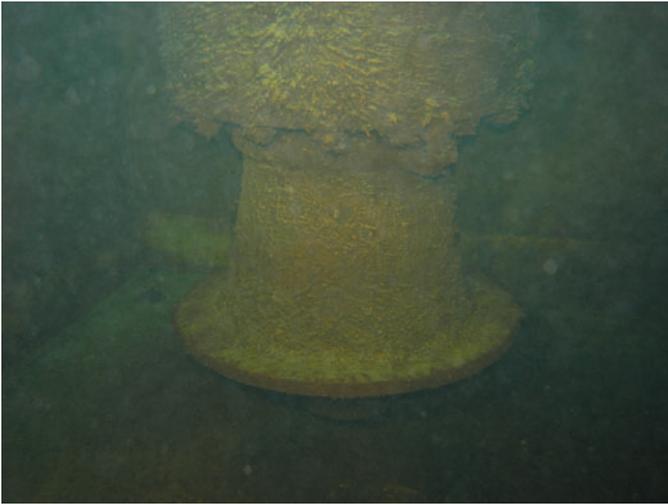
25 *Pump Column Found Unobstructed*

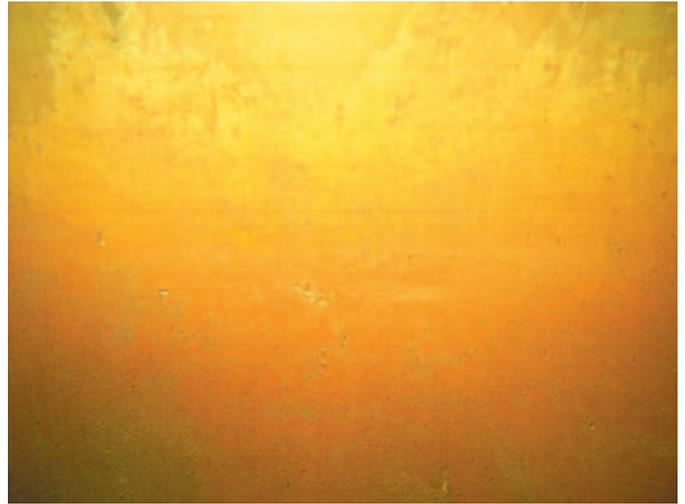
26 *Sound Interior Walls Found With Heavy Staining*

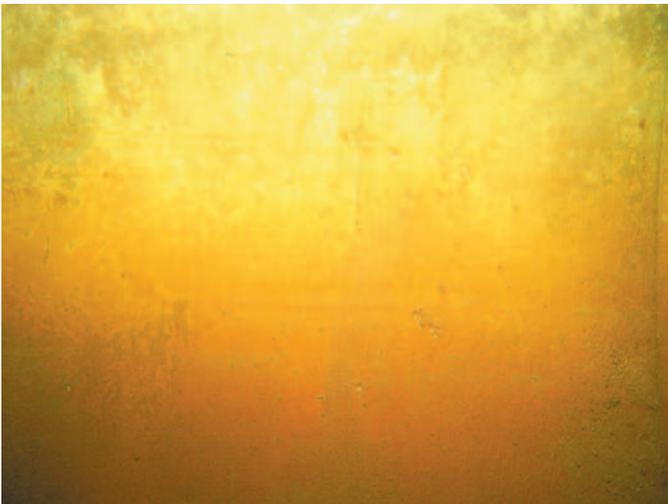
27 *Sound Interior Walls Found With Heavy Staining*

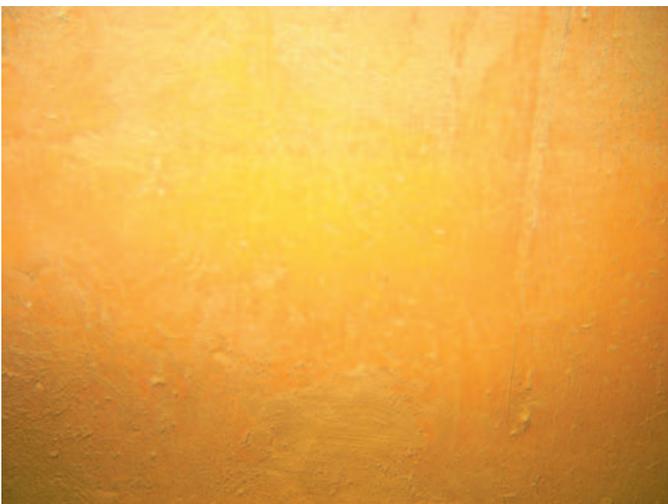
29 *Sound Interior Walls Found With Heavy Staining*

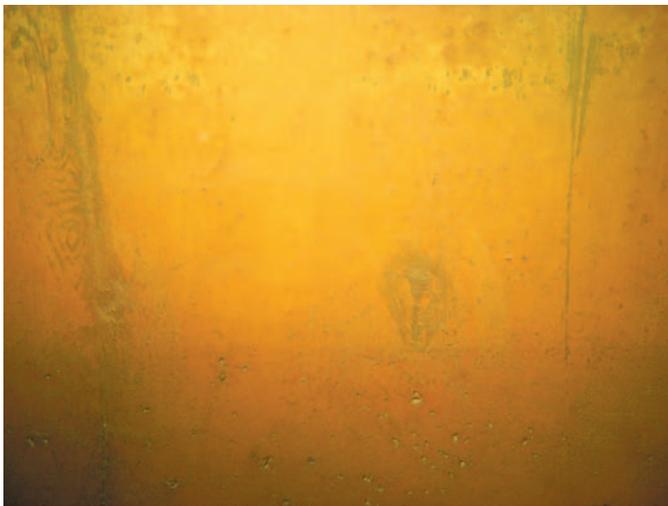
33 *Sound Interior Walls Found With Heavy Staining*

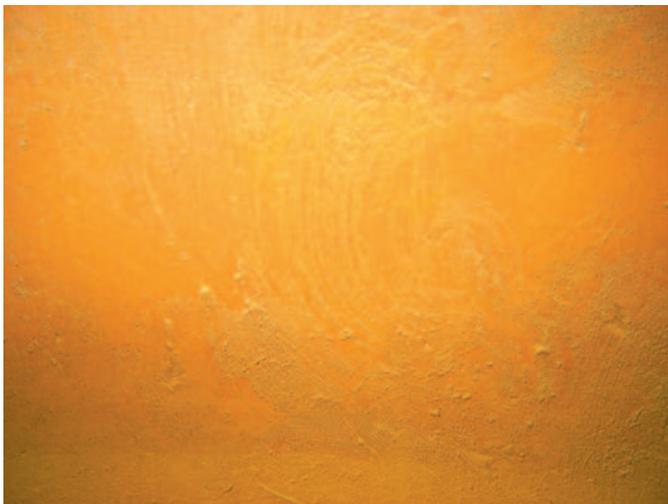
35 *Sound Interior Walls Found With Heavy Staining*

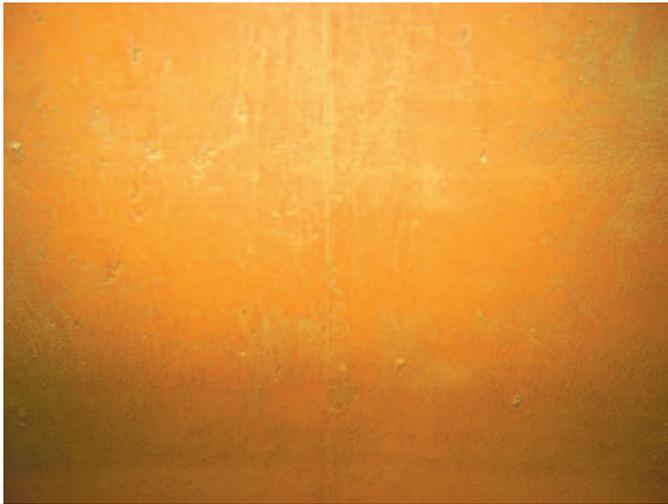
37 *Sound Interior Walls Found With Heavy Staining*

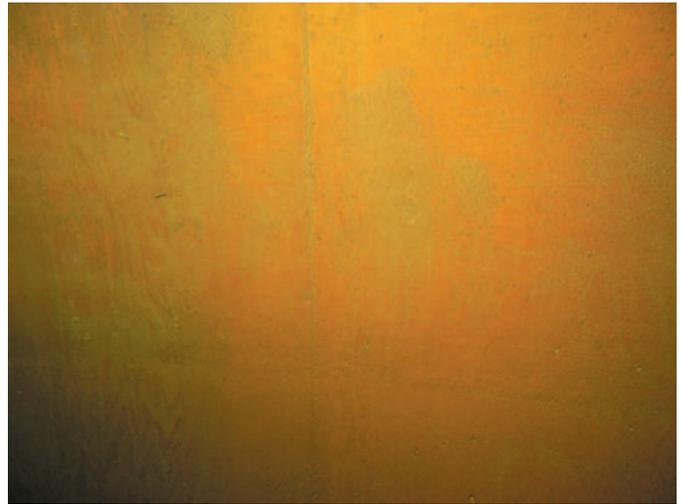
38 *Sound Interior Walls Found With Heavy Staining*

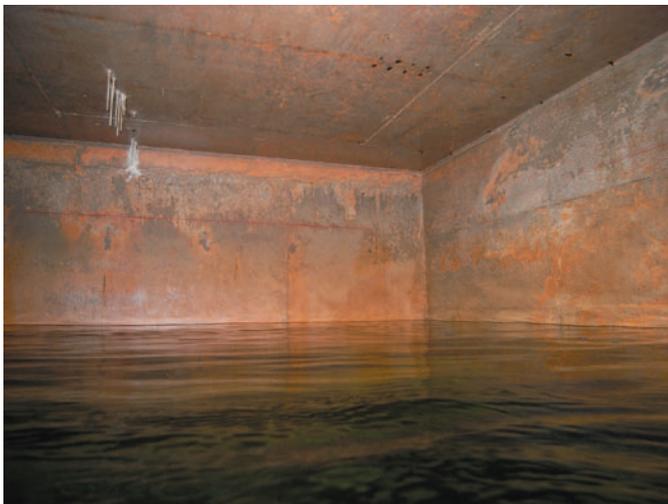
39 *Sound Interior Walls Found With Heavy Staining*

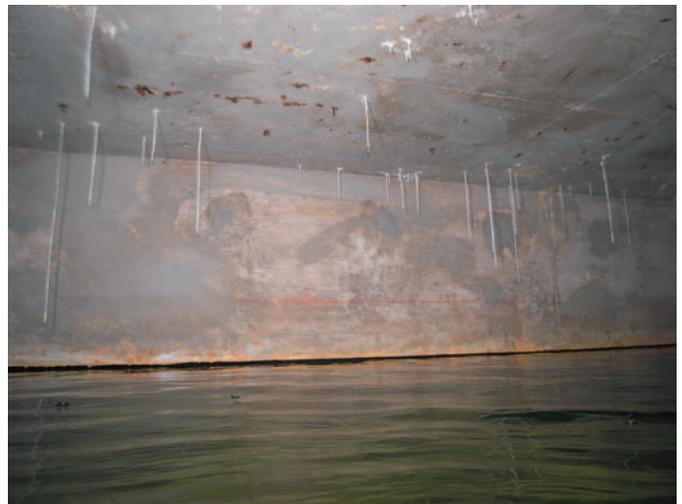
40 *Sound Interior Walls Found With Heavy Staining*

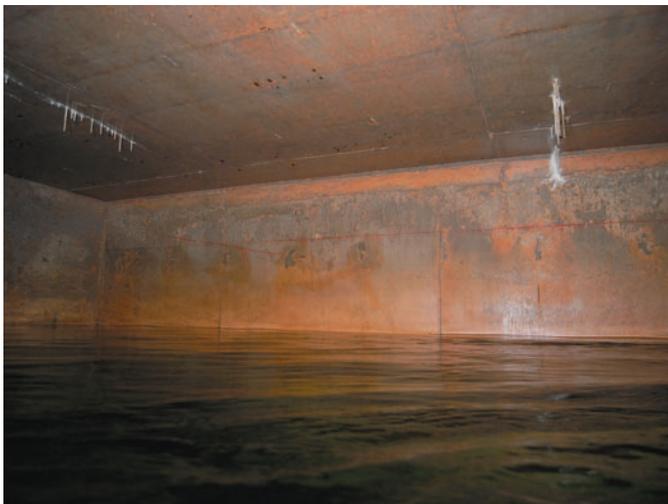
41 *Sound Interior Walls Found With Heavy Staining*

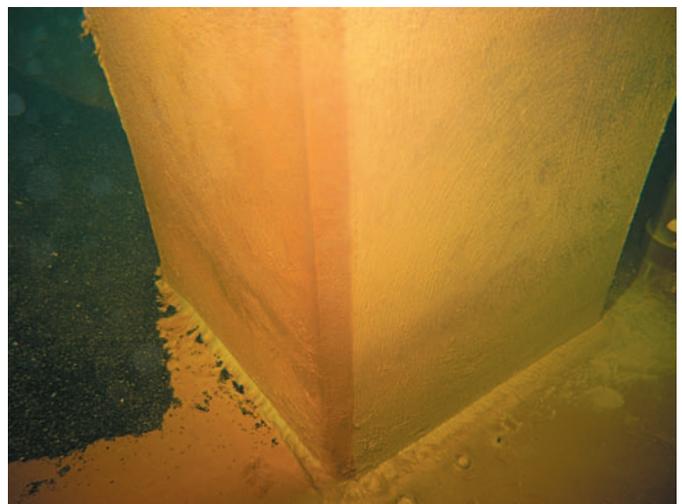
42 *One Of Seven Support Columns*

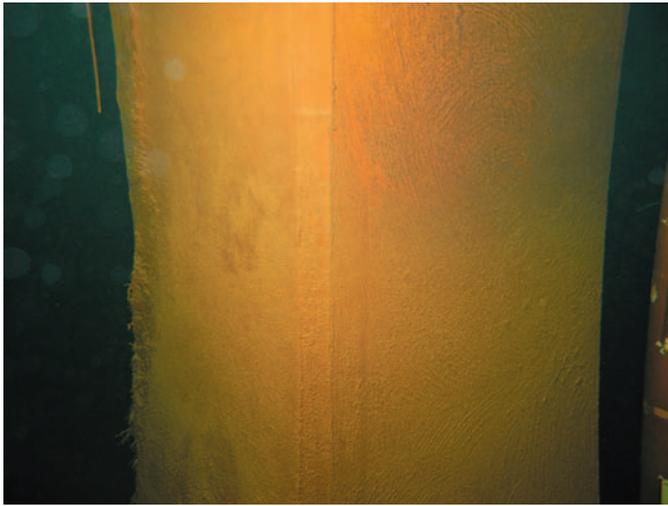
43 *One Of Seven Support Columns*

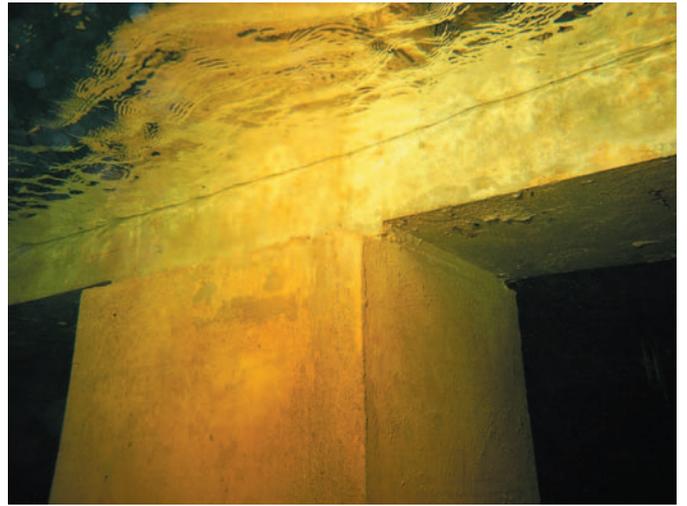
44 *One Of Seven Support Columns*

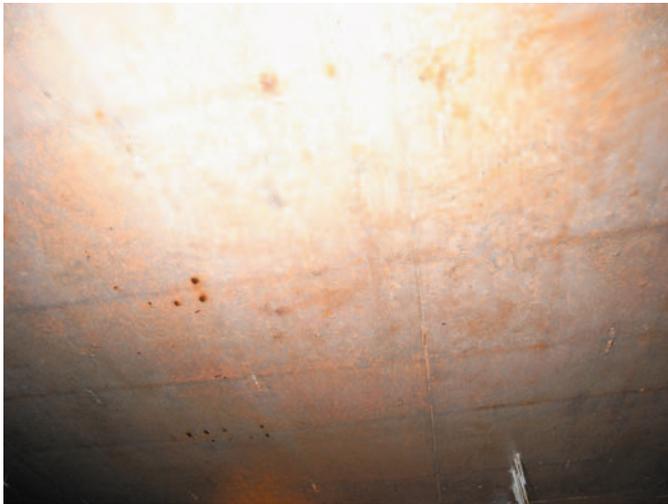
45 *Overhead Surfaces Found With Efflorescence, Stalactites And Rust Staining*

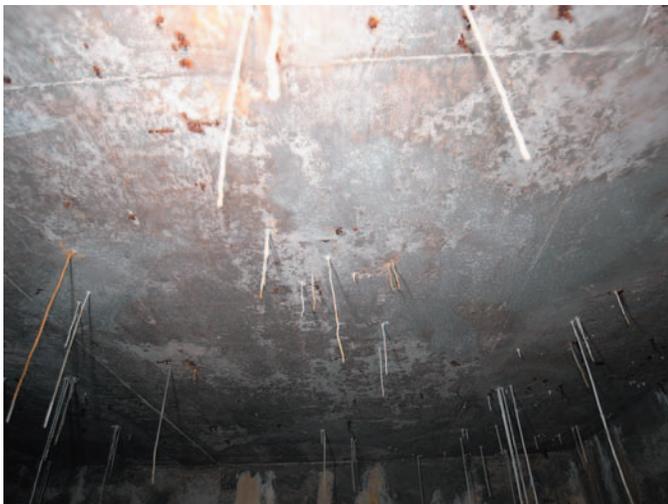
47 *Overhead Surfaces Found With Efflorescence, Stalactites And Rust Staining*
